Access Compliance Report Public Rights-of-Way (Curb Ramps)

Main Street: PROVIDENCE LN WEST Intersection ID: 23341 **Cross Street: LYNROSE CT** Location: N Initial Pass/Fail: Fail **Overall Compliance: No Severity Score:** 22.5 ADA ID: 55A60F01A92C Ramp Type: PerpDiag

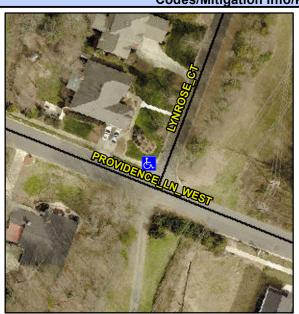
Street 1 Name **PROVIDENCE LN WEST** Stop Condition-Street 2 LYNROSE CT Street 2 Name Stop Condition-Street 1 StopSign Possible Solutions: Remove & Replace Curb Ramp With Two New Directional Ramps or Equivalent. Surveyor Notes: N/A PROW/ADA: Not Found, R304.5.1, R304.2.2, R304.5.3
