Intersection ID: 53743	Main Street: SMITH_RD	Cross Street: CANTERBURY_CASTLE_DR	Location:	SE
ADA ID: 55F20481F6A3	Ramp Type: Perp	Initial Pass/Fail: Fail	Overall Compliance: No	Severity Score: 21.25

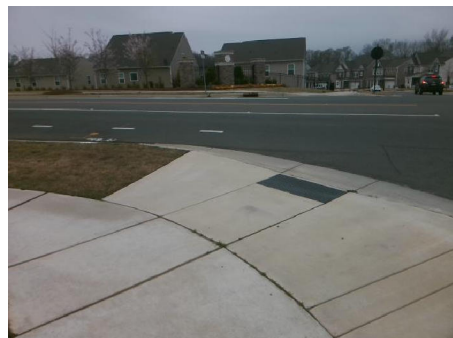
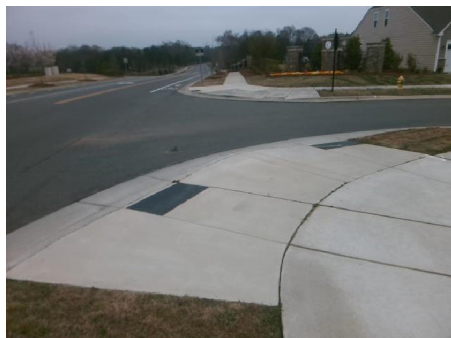
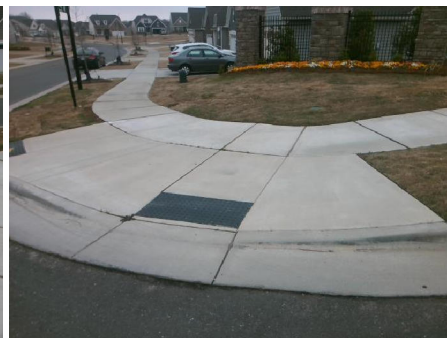
R304.5.1, R304.5.3

Possible Solutions:			Compliance	Description	Data	Compliance	Description	Data
Remove & Replace Entire Ramp.	N/A	Ramp Length (in)	94.0	Yes	Ramp Slope (%)	5.7		
	No	Ramp Width (in)	44.0	No	Ramp XSlope (%)	5.3		
	N/A	Flare Type LT	N/A	N/A	Flare Type RT	N/A		
	N/A	Flare Slope LT (%)	N/A	N/A	Flare Slope RT (%)	N/A		
	N/A	Flare Traversable LT?	N/A	N/A	Flare Traversable RT?	N/A		
	N/A	Landing Length (in)	N/A	N/A	DWS Provided?	N/A		
	N/A	Landing Width (in)	N/A	N/A	DWS Contrast?	N/A		
	N/A	Landing Slope (%)	N/A	N/A	DWS Length (in)	N/A		
	N/A	Landing X Slope (%)	N/A	N/A	DWS Full Width?	N/A		
	N/A	Landing Curb? (Y/N)	N/A	N/A	DWS Offset (in)	N/A		
	N/A	Shared Landing?	N/A					
	N/A	Gutter Ponding?	N/A	N/A	Gutter Slope (%)	N/A		
Surveyor Notes: N/A	N/A	Gutter Lip Ht (in)	1.0	N/A	Gutter X Slope (%)	N/A		
	N/A	Painted X Walk1?	No	N/A	Painted X Walk2?	N/A		
		X Walk 1 Direction	To NW		X Walk 2 Direction	N/A		
	N/A	X Walk 1 Width (in)	N/A	N/A	X Walk 2 Width (in)	N/A

X Walk 1 Slope (%)	6.0		X Walk 2 Slope (%)	N/A		
		X Walk 1 X Slope (%)	2.5		X Walk 2 X Slope (%)	N/A		
	N/A	Ramp inside XWalk1?	N/A	N/A	Ramp inside XWalk2?	N/A		
		Road Slope (%)	N/A	N/A	Clear Space?	N/A		
		Road X Slope (%)	N/A	N/A	Clear Space to XWalk (in)	N/A		
	N/A	Any Obstructions?	N/A	N/A	Storm Grate/Utility Hazard?	N/A		
		Obstruction Type			Storm Grate/Utility Type			
			N/A			N/A		
			Yes	Surface Condition? (G/P)	Good			
Total Cost:	\$	1850.00

Remove & Replace Entire Ramp.
