Access Compliance Report Public Rights-of-Way (Curb Ramps)

Intersection ID: 18166Main Street:LALEX_LNCross Street:E WOODLAWN RDLocation:SWADA ID: 561E76ABED85Ramp Type:ParaInitial Pass/Fail:FailOverall Compliance:NoSeverity Score:13.75

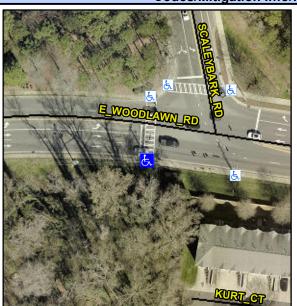
R304.3.2, R304.5.3

| Compliance Description Data Compliance Description D | | | | | |
|--|---|---|---|---|---|
| No | Ramp Slope LT (%) | 8.9 | Yes | Ramp Slope RT (%) | 5.9 |
| Yes | Ramp XSlope LT (%) | 1.7 | No | Ramp XSlope RT (%) | 2.3 |

Remove & Replace Entire Ramp.
