# Access Compliance Report

## Public Rights-of-Way

### (Curb Ramps)

Intersection ID: 26242	Main Street: BAYBROOK_LN	Cross Street: BEVINGTON_PL	Location: NW
ADA ID: 56240164DA04	Ramp Type: PerpDiag	Initial Pass/Fail: Fail	Overall Compliance: No
		Severity Score: 22.5

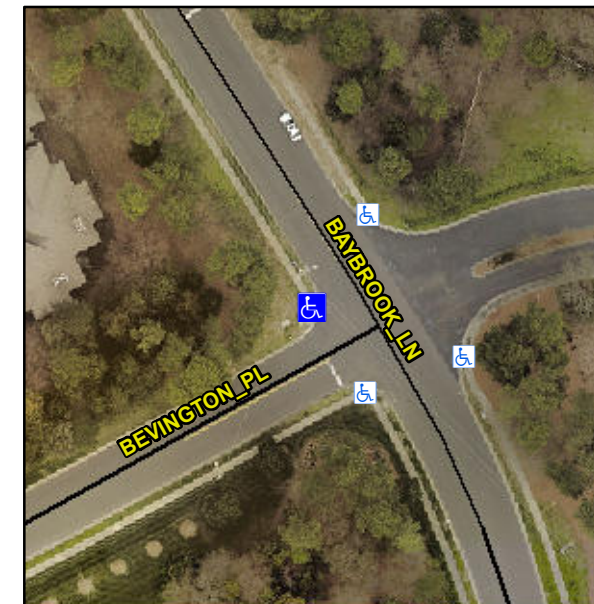
Compliance	Description	Data	Compliance	Description	Data
N/A	Ramp Length (in)	68.0	No	Ramp Slope (%)	8.6
No	Ramp Width (in)	47.5	No	Ramp XSlope (%)	4.5
N/A	Flare Type LT	N/A	N/A	Flare Type RT	N/A
N/A	Flare Slope LT (%)	N/A	N/A	Flare Slope RT (%)	N/A
N/A	Flare Traversable LT?	N/A	N/A	Flare Traversable RT?	N/A
N/A	Landing Length (in)	N/A	N/A	DWS Provided?	N/A
N/A	Landing Width (in)	N/A	N/A	DWS Contrast?	N/A
N/A	Landing Slope (%)	N/A	N/A	DWS Length (in)	N/A
N/A	Landing X Slope (%)	N/A	N/A	DWS Full Width?	N/A
N/A	Landing Curb? (Y/N)	N/A	N/A	DWS Offset (in)	N/A
N/A	Shared Landing?	N/A			
N/A	Gutter Ponding?	N/A	N/A	Gutter Slope (%)	N/A
N/A	Gutter Lip Ht (in)	N/A	N/A	Gutter X Slope (%)	N/A
N/A	Painted X Walk1?	No	N/A	Painted X Walk2?	No
	X Walk 1 Direction	To SE		X Walk 2 Direction	To NE
N/A	X Walk 1 Width (in)	N/A	N/A	X Walk 2 Width (in)	N/A
	X Walk 1 Slope (%)	3.4		X Walk 2 Slope (%)	0.3
	X Walk 1 X Slope (%)	0.5		X Walk 2 X Slope (%)	6.0

**Remove & Replace Curb Ramp With Two New Directional Ramps or Equivalent.**

**R304.5.1, R304.2.2, R304.5.3**
