Access Compliance Report

Public Rights-of-Way

| Intersection ID: 11008 | Main Street: SHAMROCK_DR | Cross Street: THE_PLAZA | Location: SE |
| ADA ID: 56AF479381D0 | Ramp Type: Para | Initial Pass/Fail: Fail | Overall Compliance: No |

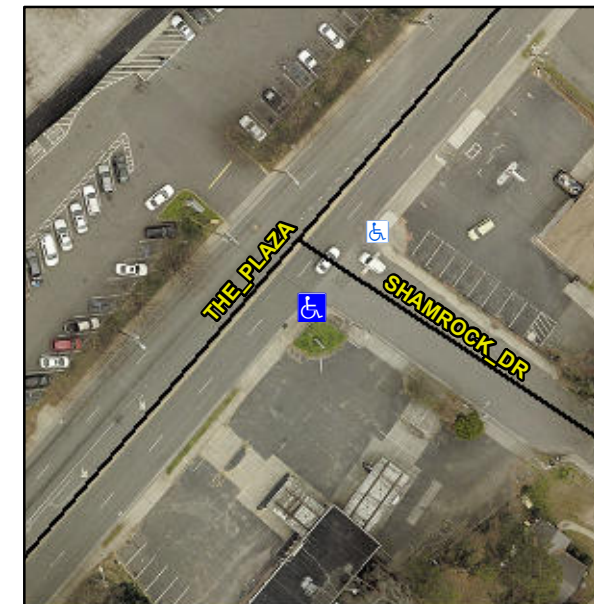
| Severity Score: 35 | | | |

LT RP < 5%

R304.5.1, R304.3.2, R304.5.3

| Compliance | Description | Data | Compliance | Description | Data |
|---|---|---|---|---|---|
| No | Ramp Width LT (in) | 37.0 | No | Ramp Width RT (in) | 44.0 |
| Yes | Ramp Slope LT (%) | 1.9 | No | Ramp Slope RT (%) | 14.1 |
| Yes | Ramp XSlope LT (%) | 1.5 | No | Ramp XSlope RT (%) | 2.6 |

Possible Solutions:

Remove & Replace Entire Ramp.
