Access Compliance Report

Public Rights-of-Way

(Curb Ramps)

| Intersection ID: 49391 | Main Street: GELBRAY_CT | Cross Street: AUBRAC_LN | Location: SE |

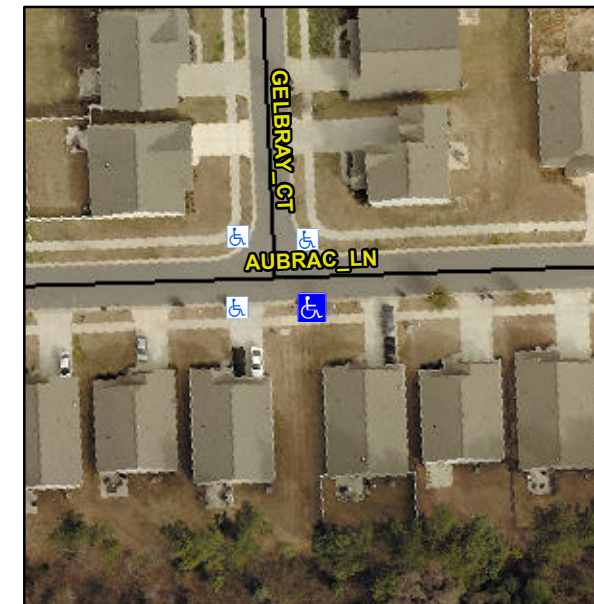
| ADA ID: 56D9E5338BD2 | Ramp Type: Perp | Initial Pass/Fail: Fail | Overall Compliance: No |

Not Found, R304.5.1

| Compliance | Description | Data | Compliance | Description | Data |
|---|---|---|---|---|---|
| No | Ramp Width (in) | 47.5 | Yes | Ramp XSlope (%) | 2.3 |

Remove & Replace Entire Ramp.
