# Access Compliance Report

## Public Rights-of-Way

### (Curb Ramps)

| Intersection ID: 28237 | Main Street: HIGHGROVE_ST | Cross Street: SOCIETY_ST | Location: SW |

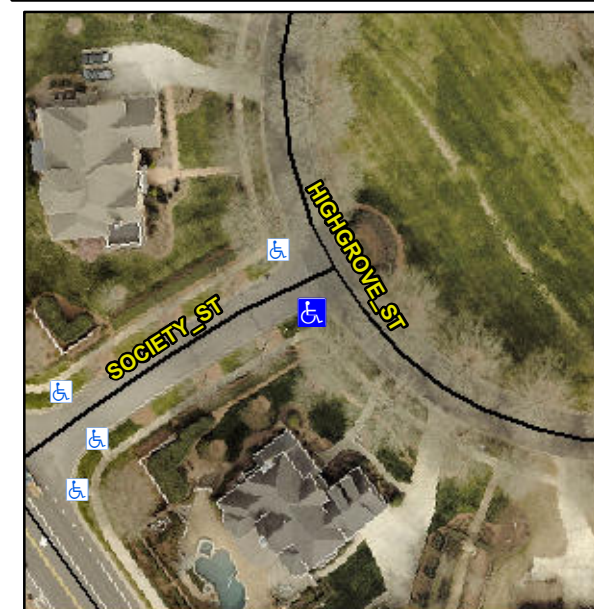
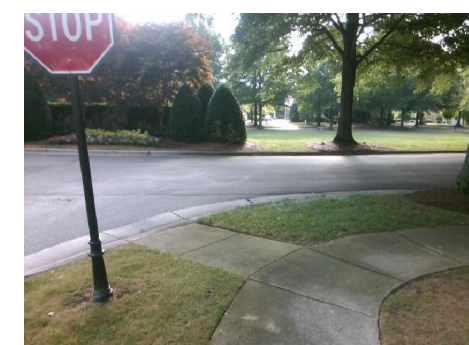
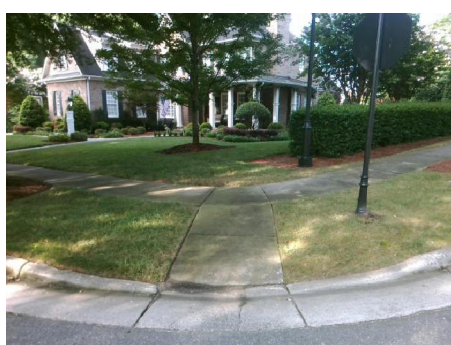
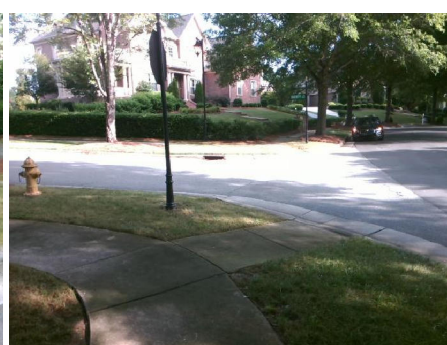
| ADA ID: 5734B15AD58B | Ramp Type: PerpDiag | Initial Pass/Fail: Fail | Overall Compliance: No |
| Severity Score: 21.25 | | | |

**R304.5.1, R304.2.2**

| Compliance | Description | Data | Compliance | Description | Data |
|---|---|---|---|---|---|
| N/A | Ramp Length (in) | 96.0 | No | Ramp Slope (%) | 8.8 |
| No | Ramp Width (in) | 47.5 | Yes | Ramp XSlope (%) | 1.6 |

**Remove & Replace Curb Ramp With Two New Directional Ramps or Equivalent.**

Total Cost: \$ 3200.00
