Access Compliance Report

Public Rights-of-Way

(Curb Ramps)

Intersection ID: 7228	Main Street: CARRINGTON_DR	Cross Street: TILDEN_RD	Location:	S
ADA ID: 573900E7DF6D	Ramp Type: Perp	Initial Pass/Fail: Fail	Overall Compliance: No	Severity Score: 13.75
Codes/Mitigation Info/Possible Solution		Field Measurements/Component Compliance

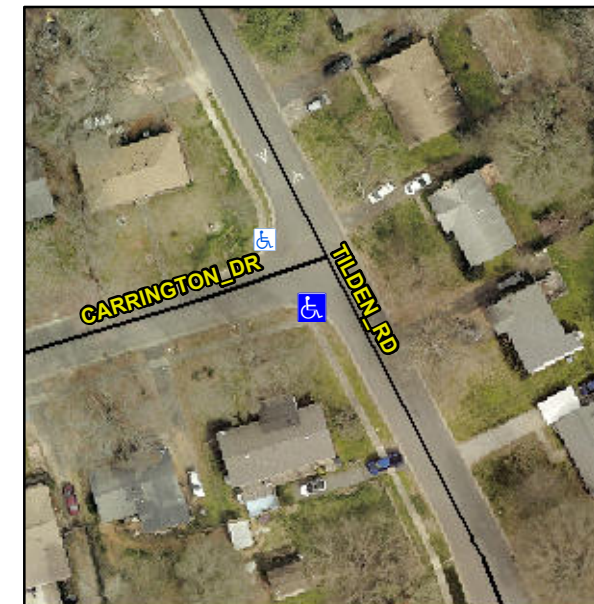
Not Found, R304.2.2, R304.5.3

Compliance	Description	Data	Compliance	Description	Data
N/A	Ramp Length (in)	42.0	No	Ramp Slope (%)	9.1
Yes	Ramp Width (in)	48.0	No	Ramp XSlope (%)	4.4
N/A	Flare Type LT	N/A	N/A	Flare Type RT	N/A
N/A	Flare Slope LT (%)	N/A	N/A	Flare Slope RT (%)	N/A
N/A	Flare Traversable LT?	N/A	N/A	Flare Traversable RT?	N/A
N/A	Landing Length (in)	N/A	N/A	DWS Provided?	N/A
N/A	Landing Width (in)	N/A	N/A	DWS Contrast?	N/A
N/A	Landing Slope (%)	N/A	N/A	DWS Length (in)	N/A
N/A	Landing X Slope (%)	N/A	N/A	DWS Full Width?	N/A
N/A	Landing Curb? (Y/N)	N/A	N/A	DWS Offset (in)	N/A
N/A	Shared Landing?	N/A			
N/A	Gutter Ponding?	N/A	N/A	Gutter Slope (%)	N/A
N/A	Gutter Lip Ht (in)	N/A	N/A	Gutter X Slope (%)	N/A
N/A	Painted X Walk1?	No	N/A	Painted X Walk2?	N/A
	X Walk 1 Direction	To N		X Walk 2 Direction	N/A
N/A	X Walk 1 Width (in)	N/A	N/A	X Walk 2 Width (in)	N/A
	X Walk 1 Slope (%)	6.3		X Walk 2 Slope (%)	N/A
	X Walk 1 X Slope (%)	2.6		X Walk 2 X Slope (%)	N/A

Possible Solutions:

Remove & Replace Entire Ramp.

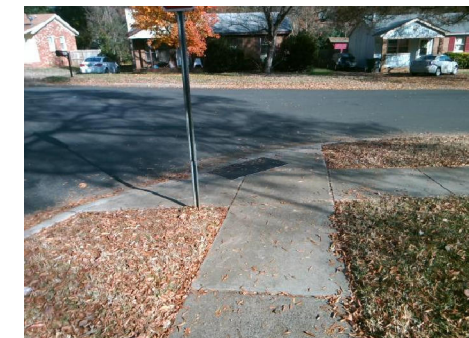
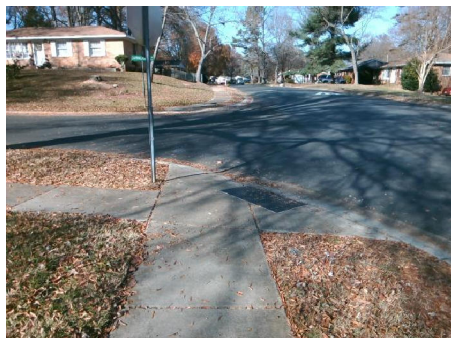
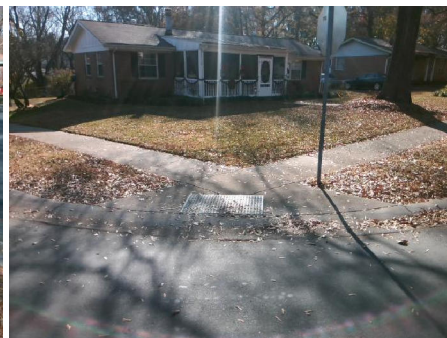
N/A	Ramp inside XWalk1?	N/A	N/A	Ramp inside XWalk2?	N/A
	Road Slope (%)	N/A	N/A	Clear Space?	N/A
	Road X Slope (%)	N/A	N/A	Clear Space to XWalk (in)	N/A
N/A	Any Obstructions?	N/A	N/A	Storm Grate/Utility Hazard?	N/A
	Obstruction Type			Storm Grate/Utility Type	
		N/A			N/A
			Yes	Surface Condition? (G/P)	Good
