Access Compliance Report

Public Rights-of-Way

(Curb Ramps)

Intersection ID: 7013	Main Street: ALDERWOOD_LN	Cross Street: ROCKY_RIVER_RD	Location: SW
ADA ID: 577EF0D42BD9	Ramp Type: Para	Initial Pass/Fail: Pass	Overall Compliance: No
Severity Score: 0			
Codes/Mitigation Info/Possible Solution		Field Measurements/Component Compliance

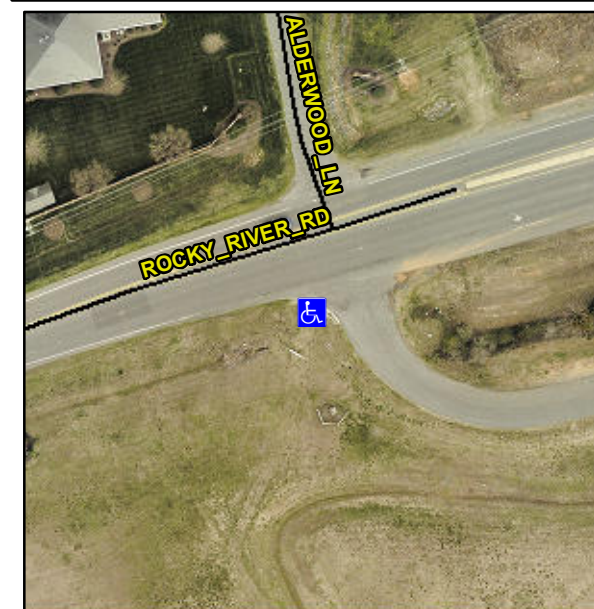
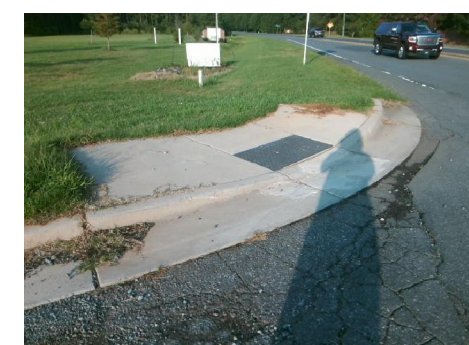
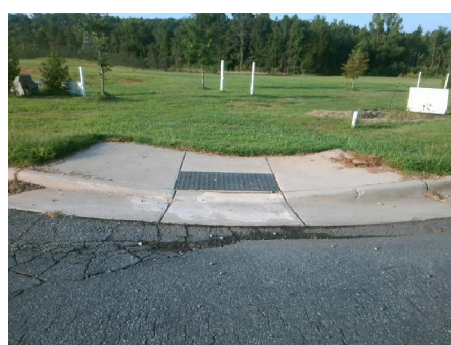
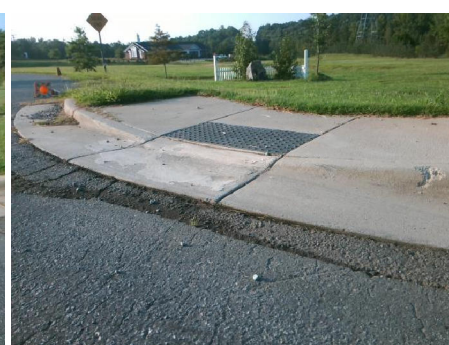
Road Slope (%)	N/A	N/A	Clear Space?	Yes
	Road X Slope (%)	N/A	N/A	Clear Space to XWalk (in)	N/A
Yes	Any Obstructions?	No	Yes	Storm Grate/Utility Hazard?	No
	Obstruction Type			Storm Grate/Utility Type	
		N/A			N/A
			Yes	Surface Condition? (G/P)	Good
			Replace	Curb Slope (%)	16.9

Possible Solutions:

Remove & Replace Entire Ramp.
