# Access Compliance Report

## Public Rights-of-Way

| Intersection ID: 27841 | Main Street: BALLANTYNE COUNTRY CLUB DR | Cross Street: OLD WAYSIDE RD | Location: S |
| ADA ID: 5782E9BFA27D | Ramp Type: BlendTrans2 | Initial Pass/Fail: Pass | Overall Compliance: No |

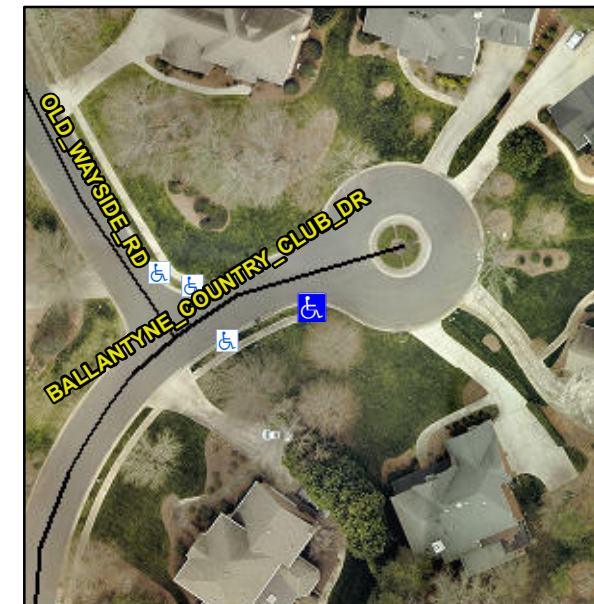
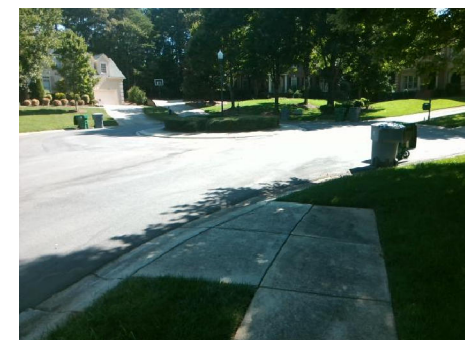
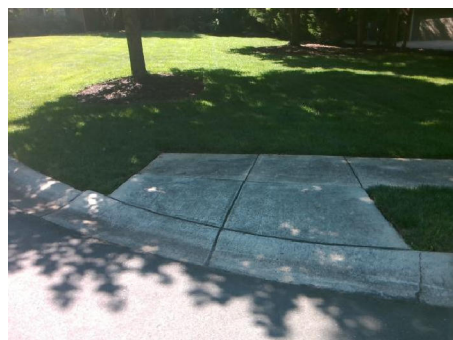
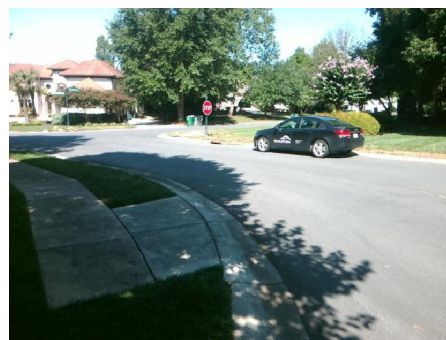
| Severity Score: 25 | | | |

**Not Found, R305, R302.7.2**

| Compliance | Description | Data | Compliance | Description | Data |
|---|---|---|---|---|---|
| N/A | Landing Length (in) | N/A | No | DWS Provided? | No |
| No | Gutter Lip Ht (in) | 1.0 | Yes | Gutter X Slope (%) | 0.6 |
| | | | No | Curb Slope (%) | 22.4 |

**Remove & Replace Curb Ramp With Two New Directional Ramps or Equivalent.**

Total Cost: \$ 3200.00
