Access Compliance Report

Public Rights-of-Way

(Curb Ramps)

| Intersection ID: 54188 | Main Street: VIZCAYA_VILLA | Cross Street: BISCAY_DR | Location: NE |

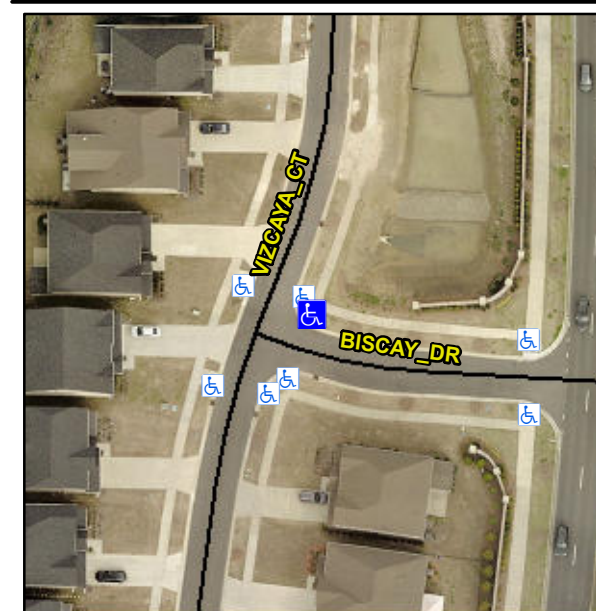
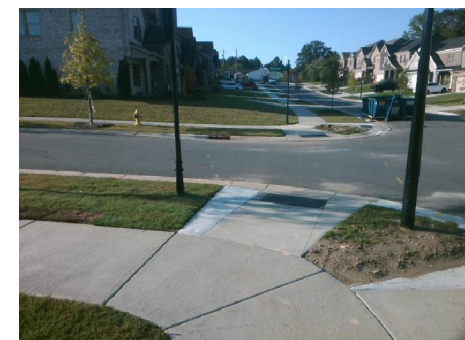
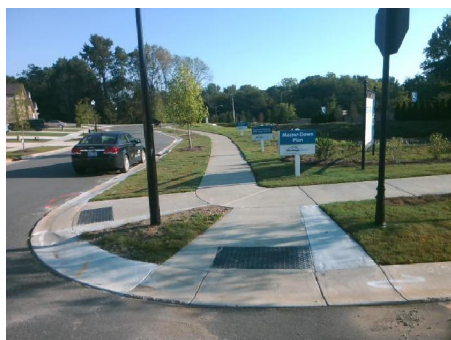
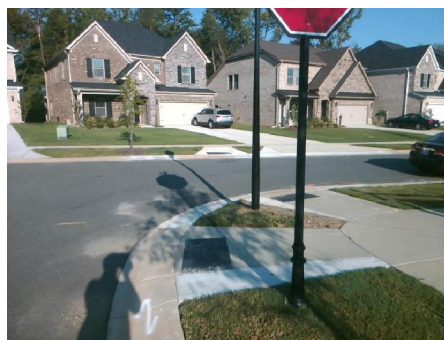
| ADA ID: 57B0435F17F5 | Ramp Type: BlendTrans1 | Initial Pass/Fail: Fail | Overall Compliance: No |
| Severity Score: 10 | | | |

Not Found, R304.5.1, R304.5.3

| Compliance | Description | Data | Compliance | Description | Data |
|---|---|---|---|---|---|
| No | Ramp Width (in) | 47.5 | No | BlendTrans XSlope (%) | 4.0 |

Remove & Replace Curb Ramp With Two New Directional Ramps or Equivalent.
