# Access Compliance Report

## Public Rights-of-Way

### (Curb Ramps)

| Intersection ID: 12157 | Main Street: MIDLAND_AV | Cross Street: AMERIGO_ST | Location: NW |

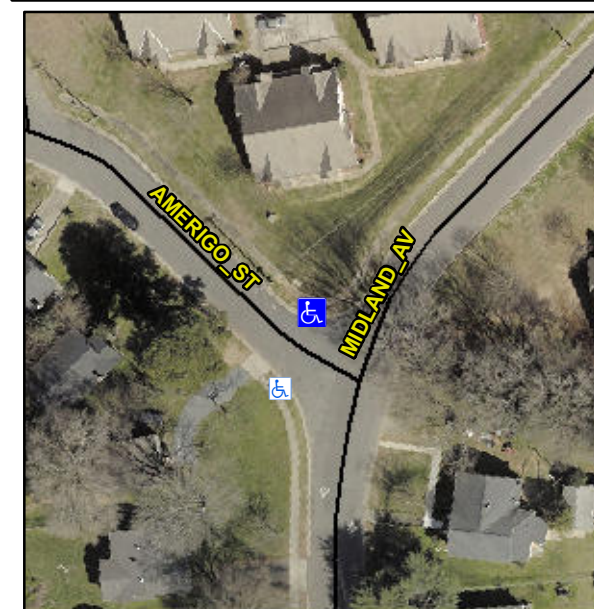
| ADA ID: 57C10E658D58 | Ramp Type: Perp | Initial Pass/Fail: Fail | Overall Compliance: No |

**R304.5.1, R304.5.3**

| Compliance | Description | Data | Compliance | Description | Data |
|---|---|---|---|---|---|
| N/A | Ramp Length (in) | 68.0 | Yes | Ramp Slope (%) | 8.0 |
| No | Ramp Width (in) | 39.5 | No | Ramp XSlope (%) | 4.8 |

**Remove & Replace Entire Ramp.**
