Access Compliance Report

Public Rights-of-Way

(Curb Ramps)

Intersection ID: 54401	Main Street: LOMA_LINDA_LN	Cross Street: AVENAL_LN	Location: NW
ADA ID: 57F4BC3A85CC	Ramp Type: Perp	Initial Pass/Fail: Fail	Overall Compliance: No
		Severity Score: 8.75

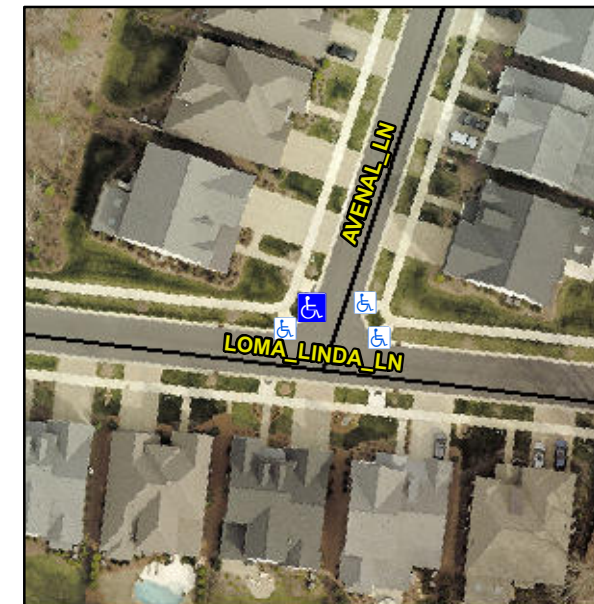
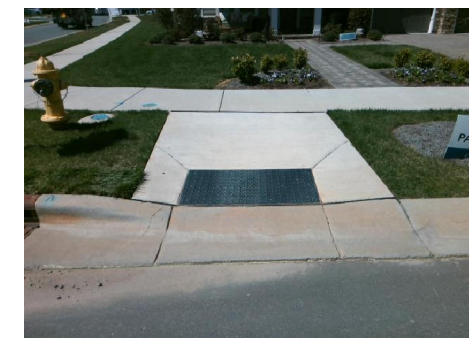
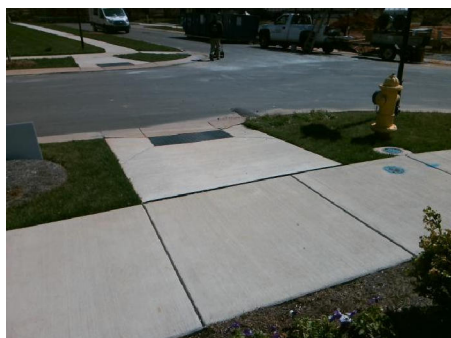
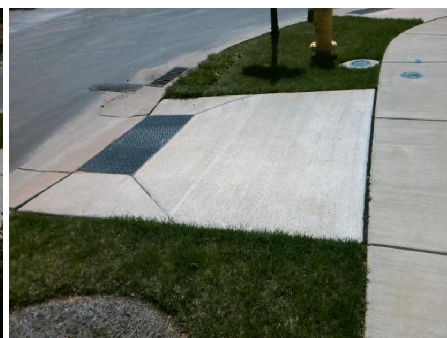
Not Found, R304.5.1

Compliance	Description	Data	Compliance	Description	Data
N/A	Ramp Length (in)	95.0	Yes	Ramp Slope (%)	7.7
No	Ramp Width (in)	47.5	Yes	Ramp XSlope (%)	0.2
N/A	Flare Type LT	N/A	N/A	Flare Type RT	N/A
N/A	Flare Slope LT (%)	N/A	N/A	Flare Slope RT (%)	N/A
N/A	Flare Traversable LT?	N/A	N/A	Flare Traversable RT?	N/A
N/A	Landing Length (in)	N/A	N/A	DWS Provided?	N/A
N/A	Landing Width (in)	N/A	N/A	DWS Contrast?	N/A
N/A	Landing Slope (%)	N/A	N/A	DWS Length (in)	N/A
N/A	Landing X Slope (%)	N/A	N/A	DWS Full Width?	N/A
N/A	Landing Curb? (Y/N)	N/A	N/A	DWS Offset (in)	N/A
N/A	Shared Landing?	N/A			
N/A	Gutter Ponding?	N/A	N/A	Gutter Slope (%)	N/A
N/A	Gutter Lip Ht (in)	N/A	N/A	Gutter X Slope (%)	N/A
N/A	Painted X Walk1?	No	N/A	Painted X Walk2?	N/A
	X Walk 1 Direction	To E		X Walk 2 Direction	N/A
N/A	X Walk 1 Width (in)	N/A	N/A	X Walk 2 Width (in)	N/A
	X Walk 1 Slope (%)	4.7		X Walk 2 Slope (%)	N/A
	X Walk 1 X Slope (%)	0.8		X Walk 2 X Slope (%)	N/A

Remove & Replace Entire Ramp.
