# Access Compliance Report

## Public Rights-of-Way

### (Curb Ramps)

Intersection ID: N/A	Main Street: COZEN_WY	Cross Street: ROTHMAN_LN	Location: SE
ADA ID: 580237F763F1	Ramp Type: Combination1Diag	Initial Pass/Fail: Fail	Overall Compliance: No
		Severity Score: 0

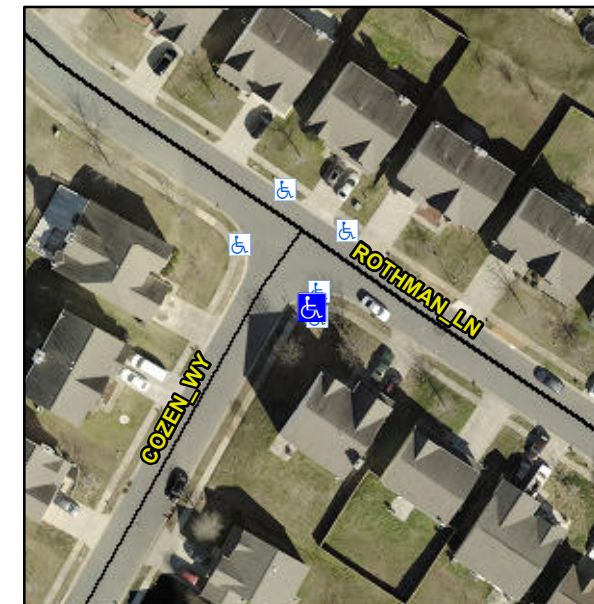
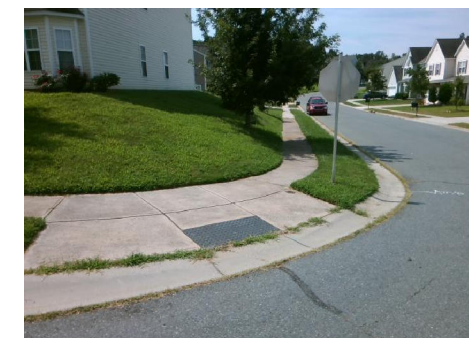
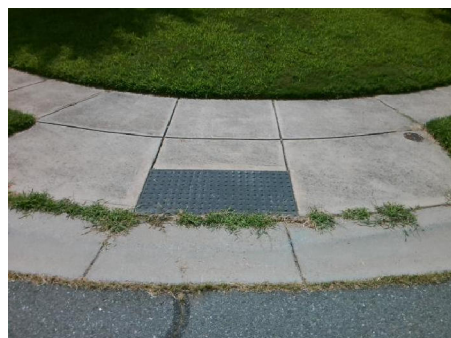
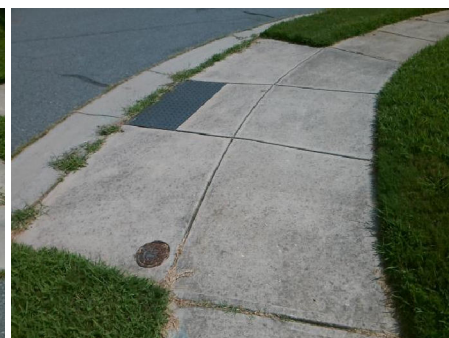
**Not Found, R304.5.1, R304.5.1, R304.2.2, R304.5.3, R304.3.2**

Compliance	Description	Data	Compliance	Description	Data
N/A	Ramp Length LT (in)	37.0	N/A	Ramp Length RT (in)	55.5
No	Ramp Width LT (in)	46.0	No	Ramp Width RT (in)	47.0
No	Ramp Slope LT (%)	10.2	Yes	Ramp Slope RT (%)	7.5
No	Ramp XSlope LT (%)	3.8	Yes	Ramp XSlope RT (%)	1.5
N/A	Ramp Length (in)	47.5	No	Ramp Slope (%)	9.8
No	Ramp Width (in)	46.5	No	Ramp XSlope (%)	6.9
N/A	Flare Type LT	N/A	N/A	Flare Type RT	N/A
N/A	Flare Slope LT (%)	N/A	N/A	Flare Slope RT (%)	N/A
N/A	Flare Traversable LT?	N/A	N/A	Flare Traversable RT?	N/A
N/A	Landing Length (in)	N/A	N/A	DWS Provided?	N/A
N/A	Landing Width (in)	N/A	N/A	DWS Contrast?	N/A
N/A	Landing Slope (%)	N/A	N/A	DWS Length (in)	N/A
N/A	Landing X Slope (%)	N/A	N/A	DWS Full Width?	N/A
N/A	Landing Curb? (Y/N)	N/A	N/A	DWS Offset (in)	N/A
N/A	Shared Landing?	N/A			
N/A	Gutter Ponding?	N/A	N/A	Gutter Slope (%)	N/A
N/A	Gutter Lip Ht (in)	N/A	N/A	Gutter X Slope (%)	N/A
N/A	Painted X Walk1?	No	N/A	Painted X Walk2?	No

X Walk 1 Direction	To NE		X Walk 2 Direction	To NW
	X Walk 1 Width (in)	N/A		X Walk 2 Width (in)	N/A
	X Walk 1 Slope (%)	3.0		X Walk 2 Slope (%)	4.7
	X Walk 1 X Slope (%)	4.7		X Walk 2 X Slope (%)	1.6
N/A	Ramp inside XWalk1?	N/A	N/A	Ramp inside XWalk2?	N/A
	Road Slope (%)	5.6		Clear Space?	N/A
	Road X Slope (%)	2.6	N/A	Clear Space to XWalk (in)	N/A
			N/A	Any Obstruction?	N/A
				Obstruction Type	N/A
			N/A	Storm Grate/Utility Hazard?	N/A
				Storm Grate/Utility Type	N/A
			Yes	Surface Condition? (G/P)	Good
				Curb Slope (%)	15.7

**Remove & Replace Curb Ramp With Two New Directional Ramps or Equivalent.**
