Access Compliance Report

Public Rights-of-Way

(Curb Ramps)

Intersection ID: 22977	Main Street: SOUTH_BV	Cross Street: MUSTANG_LN	Location: NE
ADA ID: 58098C75E7D3	Ramp Type: Perp	Initial Pass/Fail: Fail	Overall Compliance: No
		Severity Score: 8.75

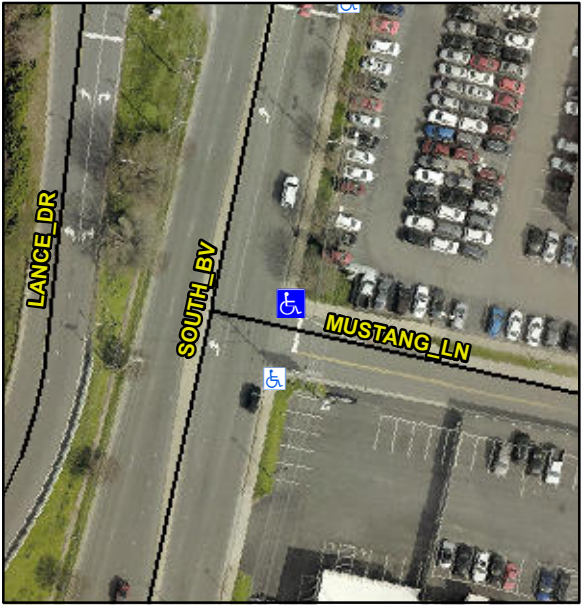
Possible Solutions:		Compliance	Description	Data
	Remove & Replace Entire Ramp.		N/A	Ramp Length (in)	71.0
			No	Ramp Width (in)	45.0
			N/A	Flare Type LT	N/A
			N/A	Flare Slope LT (%)	N/A
			N/A	Flare Traversable LT?	N/A
			N/A	Landing Length (in)	N/A
			N/A	Landing Width (in)	N/A
			N/A	Landing Slope (%)	N/A
			N/A	Landing X Slope (%)	N/A
<p>Surveyor Notes:</p> <p>N/A</p> <p>PROW/ADA:</p> <p>R304.5.1</p>			N/A	Flare Type RT	N/A
			N/A	Flare Slope RT (%)	N/A
			N/A	Flare Traversable RT?	N/A
			N/A	DWS Provided?	N/A
			N/A	DWS Contrast?	N/A
			N/A	DWS Length (in)	N/A
			N/A	DWS Full Width?	N/A
			N/A	DWS Offset (in)	N/A
			N/A	Shared Landing?	N/A
			N/A	Gutter Ponding?	N/A
			N/A	Gutter Lip Ht (in)	N/A
			N/A	Painted X Walk1?	No
				X Walk 1 Direction	To S
			N/A	X Walk 1 Width (in)	N/A
				X Walk 1 Slope (%)	0.7
				X Walk 1 X Slope (%)	1.9
