# Access Compliance Report

## Public Rights-of-Way

### (Curb Ramps)

Intersection ID: 10393	Main Street: LIMA_AV	Cross Street: ROZZELLES_FERRY_RD	Location: NE
ADA ID: 5824948DDD30	Ramp Type: PerpDiag	Initial Pass/Fail: Fail	Overall Compliance: No
Codes/Mitigation Info/Possible Solution		Field Measurements/Component Compliance	
Severity Score: 48.75

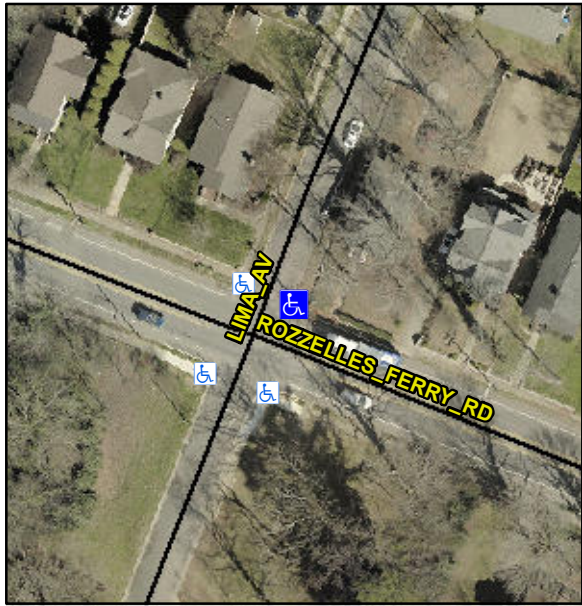
Not Found, R304.5.1, R304.2.2, R304.5.3

Compliance	Description	Data	Compliance	Description	Data
N/A	Ramp Length (in)	67.0	No	Ramp Slope (%)	9.1
No	Ramp Width (in)	31.0	No	Ramp XSlope (%)	3.2
N/A	Flare Type LT	N/A	N/A	Flare Type RT	N/A
N/A	Flare Slope LT (%)	N/A	N/A	Flare Slope RT (%)	N/A
N/A	Flare Traversable LT?	N/A	N/A	Flare Traversable RT?	N/A
N/A	Landing Length (in)	N/A	N/A	DWS Provided?	N/A
N/A	Landing Width (in)	N/A	N/A	DWS Contrast?	N/A
N/A	Landing Slope (%)	N/A	N/A	DWS Length (in)	N/A
N/A	Landing X Slope (%)	N/A	N/A	DWS Full Width?	N/A
N/A	Landing Curb? (Y/N)	N/A	N/A	DWS Offset (in)	N/A
N/A	Shared Landing?	N/A			
N/A	Gutter Ponding?	Yes	N/A	Gutter Slope (%)	N/A
N/A	Gutter Lip Ht (in)	N/A	N/A	Gutter X Slope (%)	N/A
N/A	Painted X Walk1?	No	N/A	Painted X Walk2?	No
	X Walk 1 Direction	To NW		X Walk 2 Direction	To SW
N/A	X Walk 1 Width (in)	N/A	N/A	X Walk 2 Width (in)	N/A
	X Walk 1 Slope (%)	2.6		X Walk 2 Slope (%)	3.4
	X Walk 1 X Slope (%)	2.9		X Walk 2 X Slope (%)	1.8

N/A	Ramp inside XWalk1?	N/A	N/A	Ramp inside XWalk2?	N/A
	Road Slope (%)	1.8	N/A	Clear Space?	N/A
	Road X Slope (%)	1.2	N/A	Clear Space to XWalk (in)	N/A
N/A	Any Obstructions?	N/A	N/A	Storm Grate/Utility Hazard?	N/A
	Obstruction Type			Storm Grate/Utility Type	
		N/A			N/A
			Yes	Surface Condition? (G/P)	Good

Remove & Replace Curb Ramp With Two New Directional Ramps or Equivalent.
