Access Compliance Report Public Rights-of-Way (Curb Ramps)

Intersection ID: 29264 Main Street: SEEDLING_LN Cross Street: WOODINGTON_LN Location: S

ADA ID: 585120C8D2CE Ramp Type: PerpDiag Initial Pass/Fail: Fail Overall Compliance: No Severity Score: 33.75

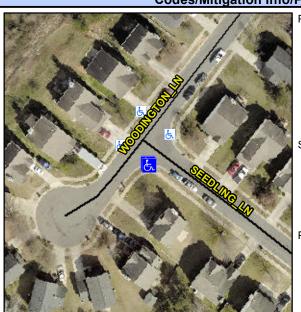
Not Found, R304.5.1, R304.5.3

| Compliance Description | | Data | Compliance Description | | Data |
|---|---|---|---|---|---|
| No | Ramp Width (in) | 41.0 | No | Ramp XSlope (%) | 12.6 |

Remove & Replace Curb Ramp With Two New Directional Ramps or Equivalent.
