# Access Compliance Report

## Public Rights-of-Way

### (Curb Ramps)

| Intersection ID: 25377 | Main Street: BRIGMORE_DR | Cross Street: CARMEL_RD | Location: S |

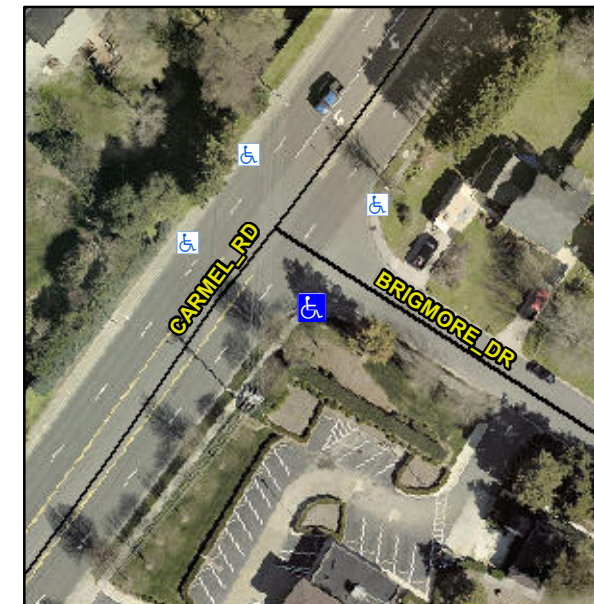
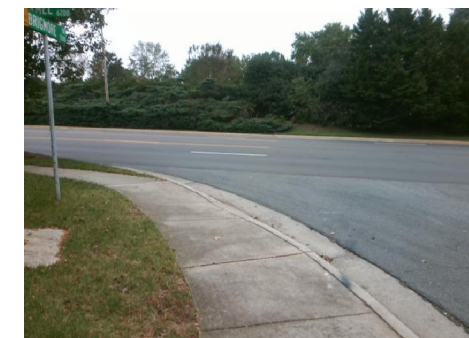
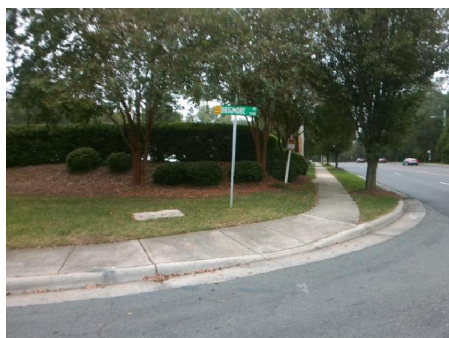
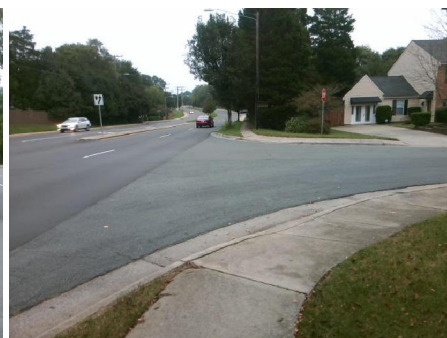
| ADA ID: 586BD3DC548A | Ramp Type: PerpDiag | Initial Pass/Fail: Fail | Overall Compliance: No |
| | | Severity Score: 35 | |

**Not Found, R304.5.1, R304.2.2, R304.5.3**

| Compliance | Description | Data | Compliance | Description | Data |
|---|---|---|---|---|---|
| N/A | Ramp Length (in) | 59.0 | No | Ramp Slope (%) | 13.5 |
| No | Ramp Width (in) | 41.0 | No | Ramp XSlope (%) | 4.9 |

**Remove & Replace Curb Ramp With Two New Directional Ramps or Equivalent.**
