# Access Compliance Report

## Public Rights-of-Way

| Intersection ID: 29959 | Main Street: STATESVILLE_RD | Cross Street: SMITH_CORNERS_BV | Location: SE |
| ADA ID: 58872DA4D3F9 | Ramp Type: Perp | Initial Pass/Fail: Fail | Overall Compliance: No |

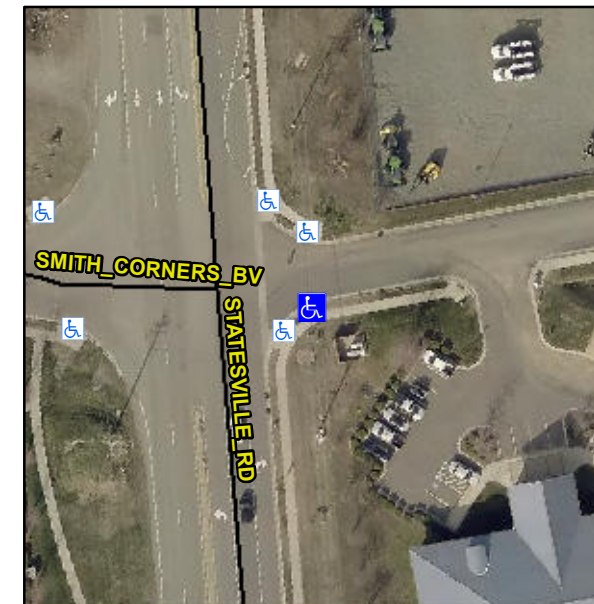
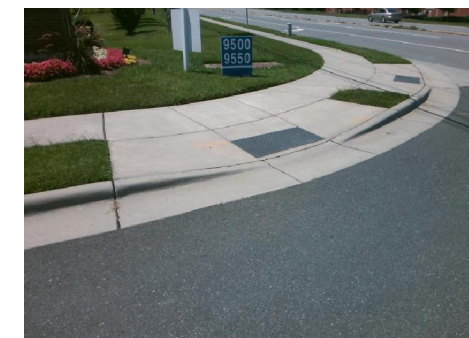
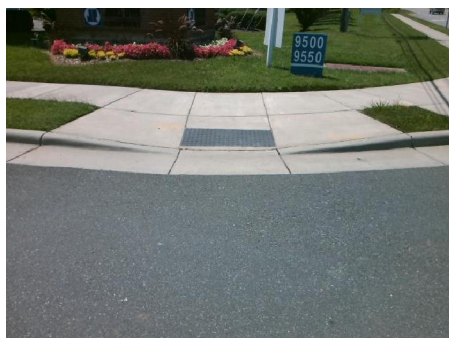
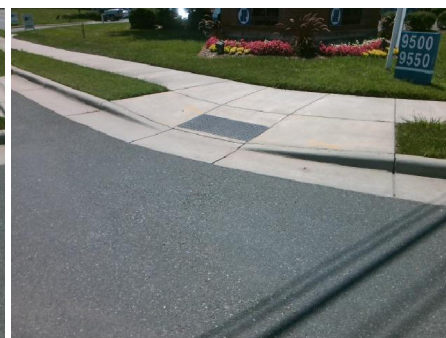
| Severity Score: 21.25 | | | |

**R304.5.1, R304.2.2**

| Compliance | Description | Data | Compliance | Description | Data |
|---|---|---|---|---|---|
| N/A | Ramp Length (in) | 47.0 | No | Ramp Slope (%) | 9.4 |
| No | Ramp Width (in) | 47.0 | Yes | Ramp XSlope (%) | 0.9 |

**Remove & Replace Entire Ramp.**

Total Cost: \$ 1850.00
