Access Compliance Report Public Rights-of-Way (Curb Ramps)

Intersection ID: 53960 Main Street: DENBUR DR **Cross Street: MAGNOLIA LILY AV** Location: NW **Overall Compliance: No ADA ID: 589140E52FEB** Ramp Type: Combination1 Initial Pass/Fail: Pass **Severity Score:** 0

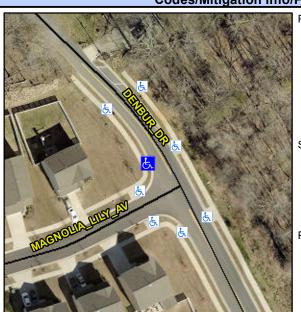
None Street 1 Name **DENBUR DR** Stop Condition-Street 1 N/A Street 2 Name Stop Condition-Street 2 N/A Possible Solutions: Compliance Description N/A Remove & Replace Entire Ramp. Yes Yes Yes N/A Yes Surveyor Notes: N/A LT RP < 5%, RT RP < 5% N/A N/A Yes Yes PROW/ADA: Yes Not Found, R302.7 Yes N/A N/A No Yes N/A
