Access Compliance Report Public Rights-of-Way (Curb Ramps)

Intersection ID: 52839 Main Street: DOCIA CROSSING RD Cross Street: ROBERT_HELMS_RD Location: SE **ADA ID: 5904BB04D0EA** Ramp Type: Perp Initial Pass/Fail: Fail **Overall Compliance: No Severity Score:** 1.25

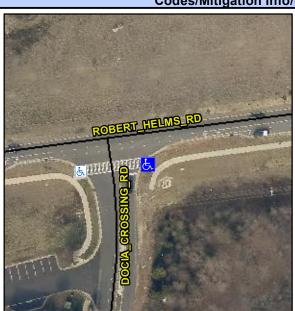
| Possible Solutions: | | | | | |
|---|--|--|--|--|--|
| R304.5.3 | | | | | |

| Field Measurements/Component Compliance | | | | | | |
|---|---|---|---|---|---|--|
| Yes | Ramp Width (in) | 48.0 | No | Ramp XSlope (%) | 2.6 | |

| Possible Solutions: | | | | | |
|---|--|--|--|--|--|
| Remove & Replace Entire Ramp. | | | | | |
