Access Compliance Report Public Rights-of-Way (Curb Ramps)

Intersection ID: 49125 Main Street: LEGOLAS_LN Cross Street: LAVETA_RD Location: SW

ADA ID: 59194112E060 Ramp Type: Combination2 Initial Pass/Fail: Fail Overall Compliance: No Severity Score: 12.5

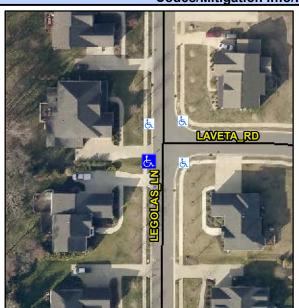
Possible Solutions:					
Remove & Replace Entire Ramp.					
Surveyor Notes:					
N/A					
PROW/ADA:					
Not Found, R304.5.1, R304.2.2					
4
