# Access Compliance Report

## Public Rights-of-Way

### (Curb Ramps)

Intersection ID: 10015564	Main Street: CENTRAL_AV	Cross Street: N/A	Location: SW
ADA ID: 599733E2A7D2	Ramp Type: Combination2Diag	Initial Pass/Fail: Fail	Overall Compliance: No
		Severity Score: 0

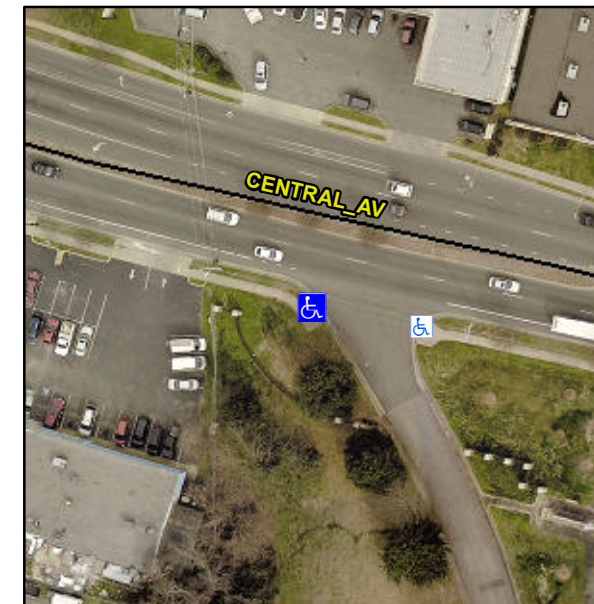
**MEDIAN ACROSS CENTRAL AV**

**Not Found, R304.5.1, R304.5.3, R304.3.2**

Compliance	Description	Data	Compliance	Description	Data
N/A	Ramp Length LT (in)	N/A	N/A	Ramp Length RT (in)	67.0
N/A	Ramp Width LT (in)	N/A	Yes	Ramp Width RT (in)	59.5
N/A	Ramp Slope LT (%)	N/A	No	Ramp Slope RT (%)	11.9
N/A	Ramp XSlope LT (%)	N/A	No	Ramp XSlope RT (%)	3.2
N/A	Ramp Length (in)	59.0	Yes	Ramp Slope (%)	3.9
No	Ramp Width (in)	46.0	No	Ramp XSlope (%)	5.8
N/A	Flare Type LT	N/A	N/A	Flare Type RT	N/A
N/A	Flare Slope LT (%)	N/A	N/A	Flare Slope RT (%)	N/A
N/A	Flare Traversable LT?	N/A	N/A	Flare Traversable RT?	N/A
N/A	Landing Length (in)	N/A	N/A	DWS Provided?	N/A
N/A	Landing Width (in)	N/A	N/A	DWS Contrast?	N/A
N/A	Landing Slope (%)	N/A	N/A	DWS Length (in)	N/A
N/A	Landing X Slope (%)	N/A	N/A	DWS Full Width?	N/A
N/A	Landing Curb? (Y/N)	N/A	N/A	DWS Offset (in)	N/A
N/A	Shared Landing?	N/A			
N/A	Gutter Ponding?	N/A	N/A	Gutter Slope (%)	N/A
N/A	Gutter Lip Ht (in)	N/A	N/A	Gutter X Slope (%)	N/A
N/A	Painted X Walk1?	No	N/A	Painted X Walk2?	No

X Walk 1 Direction	To E		X Walk 2 Direction	To N
	X Walk 1 Width (in)	N/A		X Walk 2 Width (in)	N/A
	X Walk 1 Slope (%)	0.5		X Walk 2 Slope (%)	7.5
	X Walk 1 X Slope (%)	5.4		X Walk 2 X Slope (%)	2.1
N/A	Ramp inside XWalk1?	N/A	N/A	Ramp inside XWalk2?	N/A
	Road Slope (%)	5.6		Clear Space?	N/A
	Road X Slope (%)	3.8	N/A	Clear Space to XWalk (in)	N/A
			N/A	Any Obstruction?	N/A
				Obstruction Type	N/A
			N/A	Storm Grate/Utility Hazard?	N/A
				Storm Grate/Utility Type	N/A
Yes	Surface Condition? (G/P)	Good			
	Curb Slope (%)	7.1

**Remove & Replace Curb Ramp With Two New Directional Ramps or Equivalent.**
