# Access Compliance Report

## Public Rights-of-Way

### (Curb Ramps)

Intersection ID: 28129	Main Street: OLIVIA_LN	Cross Street: ORCHID_PL	Location: NW
ADA ID: 59F6FDC6F582	Ramp Type: BlendTrans2	Initial Pass/Fail: Fail	Overall Compliance: No
Severity Score: 35			
Codes/Mitigation Info/Possible Solution		Field Measurements/Component Compliance

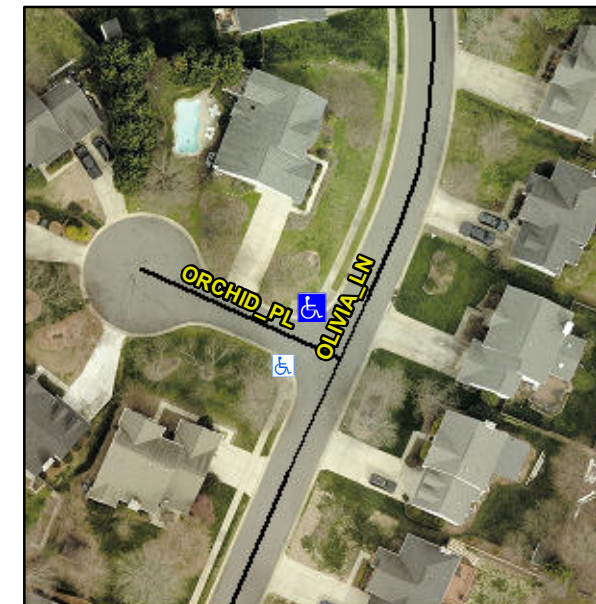
**Not Found, R304.5.1**

**Remove & Replace Curb Ramp With Two New Directional Ramps or Equivalent.**

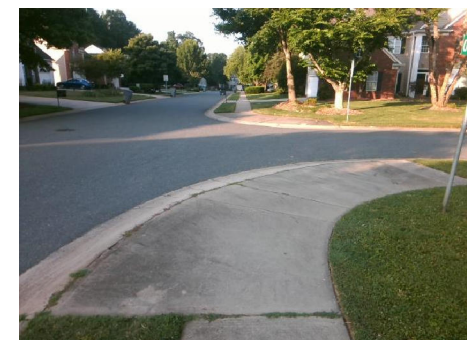
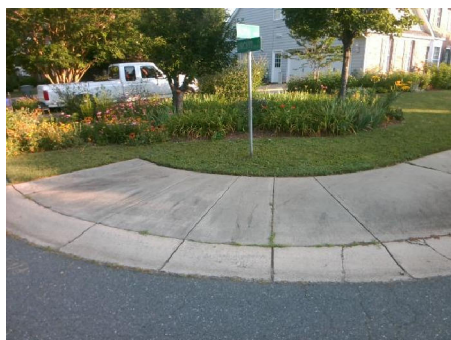
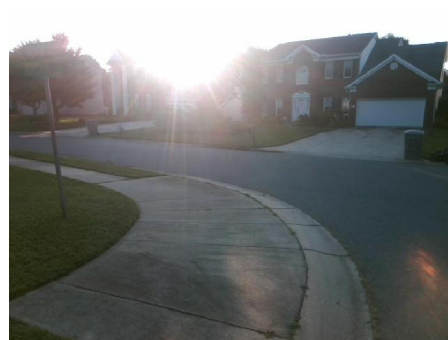
Compliance	Description	Data	Compliance	Description	Data
N/A	Ramp Length (in)	94.5	Yes	BlendTrans Slope (%)	4.8
No	Ramp Width (in)	25.0	Yes	BlendTrans XSlope (%)	0.0
N/A	Flare Type LT	N/A	N/A	Flare Type RT	N/A
N/A	Flare Slope LT (%)	N/A	N/A	Flare Slope RT (%)	N/A
N/A	Flare Traversable LT?	N/A	N/A	Flare Traversable RT?	N/A
N/A	Landing Length (in)	N/A	N/A	DWS Provided?	N/A
N/A	Landing Width (in)	N/A	N/A	DWS Contrast?	N/A
N/A	Landing Slope (%)	N/A	N/A	DWS Length (in)	N/A
N/A	Landing X Slope (%)	N/A	N/A	DWS Full Width?	N/A
N/A	Landing Curb? (Y/N)	N/A	N/A	DWS Offset (in)	N/A
N/A	Shared Landing?	N/A			
N/A	Gutter Ponding?	N/A	N/A	Gutter Slope (%)	N/A
N/A	Gutter Lip Ht (in)	N/A	N/A	Gutter X Slope (%)	N/A
N/A	Painted X Walk1?	No	N/A	Painted X Walk2?	No
	X Walk 1 Direction	To SW		X Walk 2 Direction	To SE
	X Walk 1 Width (in)	N/A		X Walk 2 Width (in)	N/A
	X Walk 1 Slope (%)	0.9		X Walk 2 Slope (%)	3.0
	X Walk 1 X Slope (%)	3.3		X Walk 2 X Slope (%)	0.0

N/A	Ramp inside XWalk1?	N/A	N/A	Ramp inside XWalk2?	N/A
	Road Slope (%)	2.1		Clear Space?	N/A
	Road X Slope (%)	4.8	N/A	Clear Space to XWalk (in)	N/A
N/A	Any Obstructions?	N/A	N/A	Storm Grate/Utility Hazard?	N/A
	Obstruction Type			Storm Grate/Utility Type	
		N/A			N/A
			Yes	Surface Condition? (G/P)	Good
			No	Curb Slope (%)	8.2
