Access Compliance Report

Public Rights-of-Way

| Intersection ID: 53003 | Main Street: VICTORIA_BROOK_LN | Cross Street: BRITTANY_DAWN_PL | Location: SE |
| ADA ID: 59FD2F2B876E | Ramp Type: PerpDiag | Initial Pass/Fail: Fail | Overall Compliance: No |

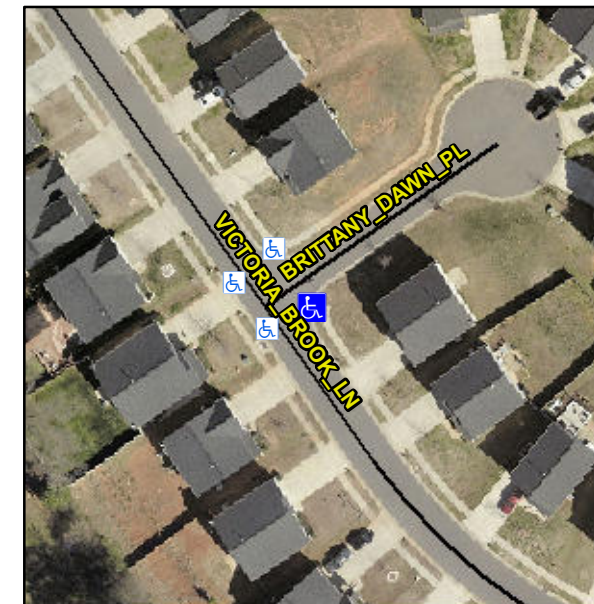
| Severity Score: 21.25 | | | |

Not Found, R304.5.1, R304.2.2

| Compliance | Description | Data | Compliance | Description | Data |
|---|---|---|---|---|---|
| N/A | Ramp Length (in) | 48.0 | No | Ramp Slope (%) | 9.2 |
| No | Ramp Width (in) | 47.0 | Yes | Ramp XSlope (%) | 1.4 |

Remove & Replace Curb Ramp With Two New Directional Ramps or Equivalent.
