## Access Compliance Report Public Rights-of-Way (Curb Ramps)

Intersection ID: 27494Main Street:BALLANTYNE\_COMMONS\_PY Cross Street:SUMMIT\_COMMONS\_BVLocation:NEADA ID: 5A66838367BERamp Type:PerpInitial Pass/Fail:FailOverall Compliance:NoSeverity Score:10

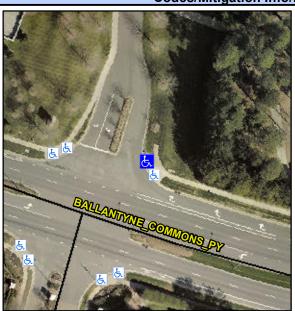
Not Found, R304.5.1, R304.5.3

| Field Measurements/Component Compliance | | | | | |
|---|---|---|---|---|---|
| No | Ramp Width (in) | 46.5 | No | Ramp XSlope (%) | 3.5 |

Remove & Replace Entire Ramp.
