Access Compliance Report

Public Rights-of-Way

(Curb Ramps)

| Intersection ID: 4679 | Main Street: HERITAGE_POINTE_RD | Cross Street: US_29_ACCESS_RD | Location: W |

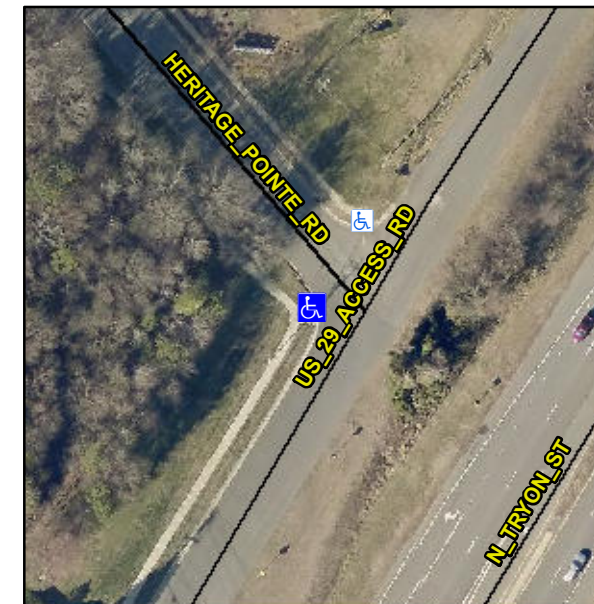
| ADA ID: 5A718368DA59 | Ramp Type: Perp | Initial Pass/Fail: Fail | Overall Compliance: No |
| Severity Score: 21.25 | | | |

R304.5.1, R304.2.2

| Compliance | Description | Data | Compliance | Description | Data |
|---|---|---|---|---|---|
| N/A | Ramp Length (in) | 98.0 | No | Ramp Slope (%) | 8.6 |
| No | Ramp Width (in) | 39.0 | Yes | Ramp XSlope (%) | 0.4 |

Remove & Replace Entire Ramp.

Total Cost: \$ 1850.00
