Access Compliance Report Public Rights-of-Way (Curb Ramps)

Intersection ID: 10027081 Main Street: GALLERIA BV **Cross Street: N/A** Location: NE **ADA ID: 5AB577B490AC** Ramp Type: PerpDiag Initial Pass/Fail: Fail **Overall Compliance: No Severity Score:** 42.5

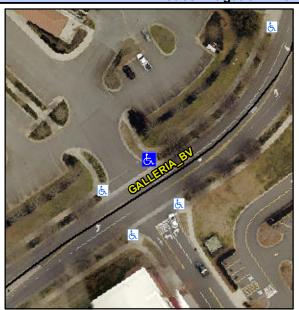
Field Measurements/Component Compliance					
Comp	liance Description	Data	Comp	liance Description	Data
N/A	Ramp Length (in)	95.0	No	Ramp Slope (%)	10.4
No	Ramp Width (in)	34.0	No	Ramp XSlope (%)	6.0
N/A	Flare Type LT	N/A	N/A	Flare Type RT	N/A
N/A	Flare Slope LT (%)	N/A	N/A	Flare Slope RT (%)	N/A
N/A	Flare Traversable LT?	N/A	N/A	Flare Traversable RT?	N/A
N/A	Landing Length (in)	N/A	N/A	DWS Provided?	N/A
N/A	Landing Width (in)	N/A	N/A	DWS Contrast?	N/A
N/A	Landing Slope (%)	N/A	N/A	DWS Length (in)	N/A
N/A	Landing X Slope (%)	N/A	N/A	DWS Full Width?	N/A
N/A	Landing Curb? (Y/N)	N/A	N/A	DWS Offset (in)	N/A
N/A	Shared Landing?	N/A			
N/A	Gutter Ponding?	N/A	N/A	Gutter Slope (%)	N/A
N/A	Gutter Lip Ht (in)	N/A	N/A	Gutter X Slope (%)	N/A
N/A	Painted X Walk1?	No	N/A	Painted X Walk2?	No
	X Walk 1 Direction	To W		X Walk 2 Direction	To S
N/A	X Walk 1 Width (in)	N/A	N/A	X Walk 2 Width (in)	N/A
	X Walk 1 Slope (%)	0.3		X Walk 2 Slope (%)	1.2

X Walk 1 X Slope (%)	3.0		X Walk 2 X Slope (%)	1.5
N/A	Ramp inside XWalk1?	N/A	N/A	Ramp inside XWalk2?	N/A
	Road Slope (%)	1.5	N/A	Clear Space?	N/A
	Road X Slope (%)	1.3	N/A	Clear Space to XWalk (in)	N/A
N/A	Any Obstructions?	N/A	N/A	Storm Grate/Utility Hazard?	N/A
	Obstruction Type			Storm Grate/Utility Type	
		N/A			N/A
			Yes	Surface Condition? (G/P)	Good

Possible Solutions: Remove & Replace Curb Ramp With Two New Directional Ramps or Equivalent. Surveyor Notes: N/A PROW/ADA: Not Found, R304.5.1, R304.2.2, R304.5.3
