Access Compliance Report

Public Rights-of-Way

(Curb Ramps)

Intersection ID: 11133	Main Street: COLEBROOK_RD	Cross Street: MALTA_PL	Location:	N
ADA ID: 5B498BCA3588	Ramp Type: Perp	Initial Pass/Fail: Fail	Overall Compliance: No	Severity Score: 10

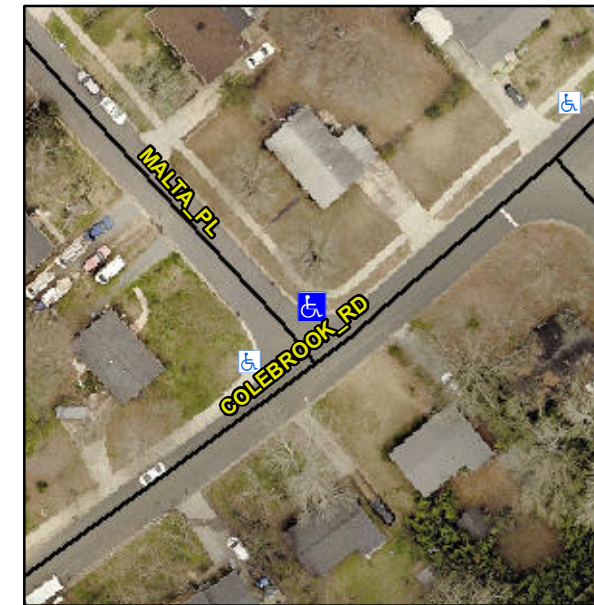
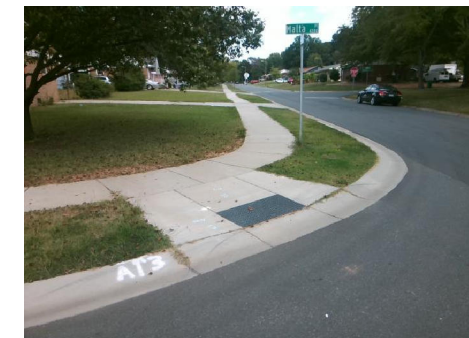
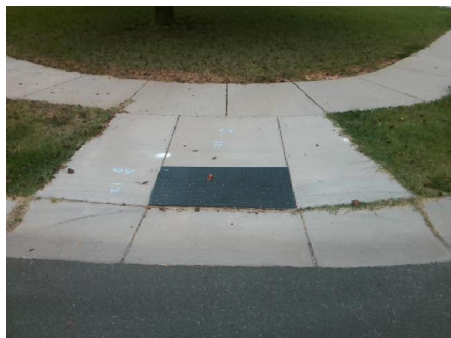
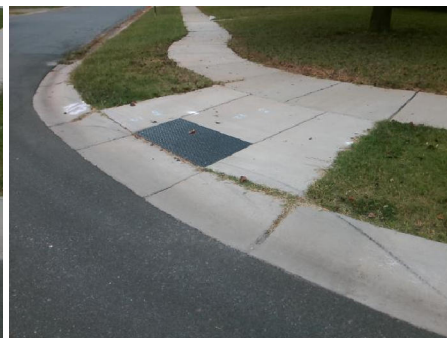
R304.5.1, R304.5.3

Compliance	Description	Data	Compliance	Description	Data
N/A	Ramp Length (in)	72.0	Yes	Ramp Slope (%)	7.2
No	Ramp Width (in)	47.0	No	Ramp XSlope (%)	2.4
N/A	Flare Type LT	N/A	N/A	Flare Type RT	N/A
N/A	Flare Slope LT (%)	N/A	N/A	Flare Slope RT (%)	N/A
N/A	Flare Traversable LT?	N/A	N/A	Flare Traversable RT?	N/A
N/A	Landing Length (in)	N/A	N/A	DWS Provided?	N/A
N/A	Landing Width (in)	N/A	N/A	DWS Contrast?	N/A
N/A	Landing Slope (%)	N/A	N/A	DWS Length (in)	N/A
N/A	Landing X Slope (%)	N/A	N/A	DWS Full Width?	N/A
N/A	Landing Curb? (Y/N)	N/A	N/A	DWS Offset (in)	N/A
N/A	Shared Landing?	N/A			
N/A	Gutter Ponding?	N/A	N/A	Gutter Slope (%)	N/A
N/A	Gutter Lip Ht (in)	N/A	N/A	Gutter X Slope (%)	N/A
N/A	Painted X Walk1?	No	N/A	Painted X Walk2?	N/A
	X Walk 1 Direction	To SW		X Walk 2 Direction	N/A
N/A	X Walk 1 Width (in)	N/A	N/A	X Walk 2 Width (in)	N/A
	X Walk 1 Slope (%)	1.7		X Walk 2 Slope (%)	N/A
	X Walk 1 X Slope (%)	0.4		X Walk 2 X Slope (%)	N/A

Remove & Replace Entire Ramp.
