Access Compliance Report

Public Rights-of-Way

(Curb Ramps)

Intersection ID: 42495	Main Street: ALMA_BLOUNT_BV	Cross Street: TOLLESON_AV	Location: NW
ADA ID: 5B6AA16BDDA9	Ramp Type: Combination1Diag	Initial Pass/Fail: Fail	Overall Compliance: No
		Severity Score: 0

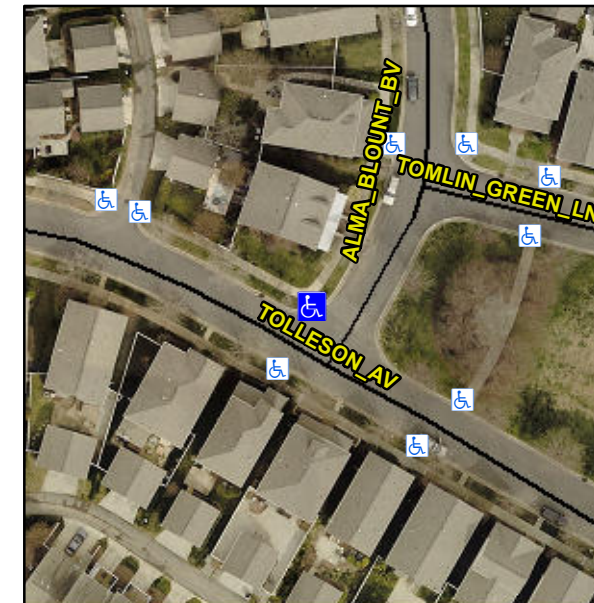
LT RP < 5%

R304.5.1, R304.5.3

Compliance	Description	Data	Compliance	Description	Data
N/A	Ramp Length LT (in)	28.0	N/A	Ramp Length RT (in)	35.0
Yes	Ramp Width LT (in)	48.0	Yes	Ramp Width RT (in)	60.0
Yes	Ramp Slope LT (%)	4.0	Yes	Ramp Slope RT (%)	7.0
Yes	Ramp XSlope LT (%)	2.0	No	Ramp XSlope RT (%)	2.5
N/A	Ramp Length (in)	72.0	Yes	Ramp Slope (%)	7.8
No	Ramp Width (in)	38.0	Yes	Ramp XSlope (%)	1.4
N/A	Flare Type LT	N/A	N/A	Flare Type RT	N/A
N/A	Flare Slope LT (%)	N/A	N/A	Flare Slope RT (%)	N/A
N/A	Flare Traversable LT?	N/A	N/A	Flare Traversable RT?	N/A
N/A	Landing Length (in)	N/A	N/A	DWS Provided?	N/A
N/A	Landing Width (in)	N/A	N/A	DWS Contrast?	N/A
N/A	Landing Slope (%)	N/A	N/A	DWS Length (in)	N/A
N/A	Landing X Slope (%)	N/A	N/A	DWS Full Width?	N/A
N/A	Landing Curb? (Y/N)	N/A	N/A	DWS Offset (in)	N/A
N/A	Shared Landing?	N/A			
N/A	Gutter Ponding?	N/A	N/A	Gutter Slope (%)	N/A
N/A	Gutter Lip Ht (in)	N/A	N/A	Gutter X Slope (%)	N/A
N/A	Painted X Walk1?	No	N/A	Painted X Walk2?	No

Remove & Replace Curb Ramp With Two New Directional Ramps or Equivalent.
