Access Compliance Report

Public Rights-of-Way

(Curb Ramps)

Intersection ID: 48458	Main Street: QUINN_DR	Cross Street: FOX_POINT_DR	Location: S
ADA ID: 5B6B098EA501	Ramp Type: Perp	Initial Pass/Fail: Fail	Overall Compliance: No
		Severity Score: 12.5

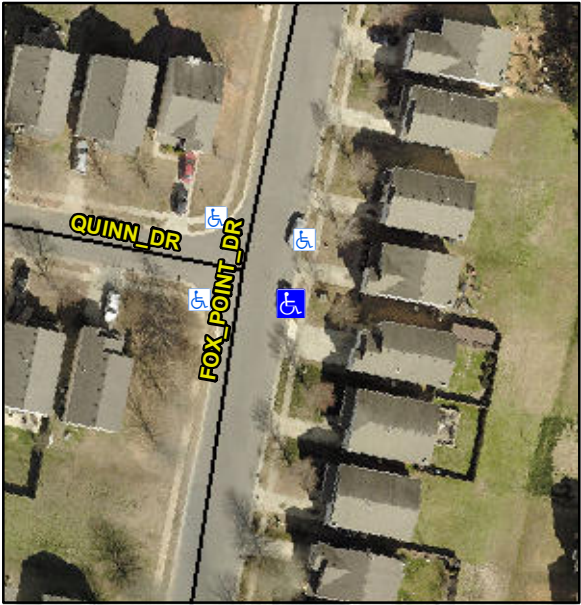
Possible Solutions:		Compliance	Description	Data
	Remove & Replace Entire Ramp.		No	Ramp Length (in)	48.0
			Yes	Ramp Width (in)	48.0
			N/A	Flare Type LT	N/A
			N/A	Flare Slope LT (%)	N/A
			N/A	Flare Traversable LT?	N/A
			N/A	Landing Length (in)	N/A
			N/A	Landing Width (in)	N/A
			N/A	Landing Slope (%)	N/A
			N/A	Landing X Slope (%)	N/A
<p>Surveyor Notes:</p> <p>N/A</p> <p>PROW/ADA:</p> <p>Not Found, R304.2.2</p>			N/A	Flare Type RT	N/A
			N/A	Flare Slope RT (%)	N/A
			N/A	Flare Traversable RT?	N/A
			N/A	DWS Provided?	N/A
			N/A	DWS Contrast?	N/A
			N/A	DWS Length (in)	N/A
			N/A	DWS Full Width?	N/A
			N/A	DWS Offset (in)	N/A
			N/A	Gutter Ponding?	N/A
			N/A	Gutter Lip Ht (in)	N/A
			No	Painted X Walk1?	N/A
				X Walk 1 Direction	To NW
			N/A	X Walk 1 Width (in)	N/A
				X Walk 1 Slope (%)	2.5
				X Walk 1 X Slope (%)	2.0

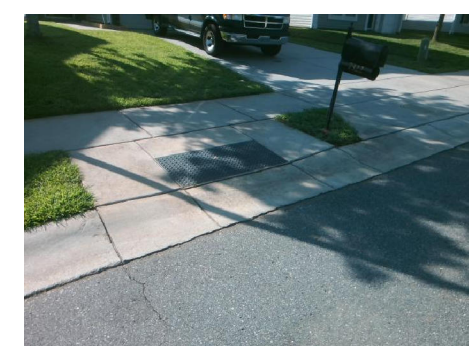
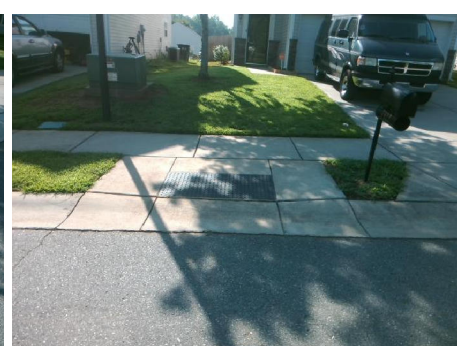
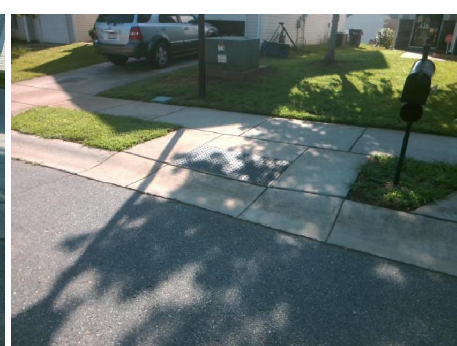
N/A	Ramp inside XWalk1?	N/A
			N/A	Road Slope (%)	N/A
			N/A	Road X Slope (%)	N/A
			N/A	Any Obstructions?	N/A
				Obstruction Type	
Total Cost:		\$ 1850.00	N/A	Storm Grate/Utility Hazard?	N/A
			N/A	Storm Grate/Utility Type	N/A
			Yes	Surface Condition? (G/P)	Good
