# Access Compliance Report

## Public Rights-of-Way

| Intersection ID: 47847 | Main Street: ALVARADO_WY | Cross Street: CACTUS_VALLEY_RD | Location: SE |
| ADA ID: 5B77B3B06CA8 | Ramp Type: PerpDiag | Initial Pass/Fail: Fail | Overall Compliance: No |

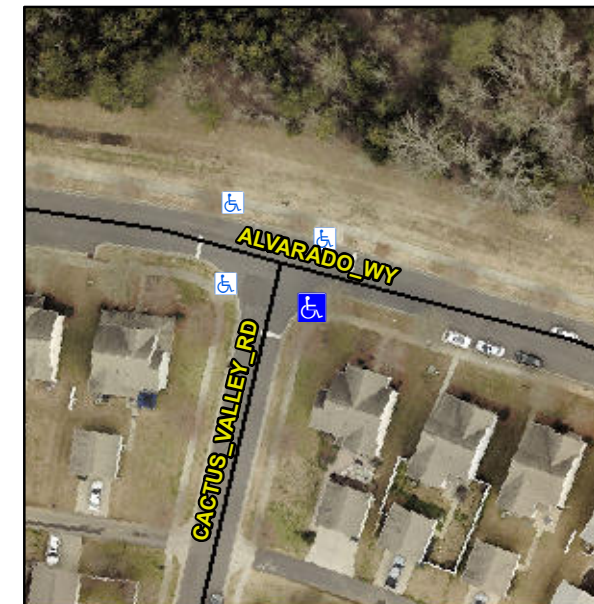
| Severity Score: 8.75 | | | |

**R304.5.1**

| Compliance | Description | Data | Compliance | Description | Data |
|---|---|---|---|---|---|
| No | Ramp Width (in) | 46.0 | Yes | Ramp XSlope (%) | 1.2 |

**Remove & Replace Curb Ramp With Two New Directional Ramps or Equivalent.**

Total Cost: \$ 3200.00
