# Access Compliance Report

## Public Rights-of-Way

### (Curb Ramps)

| Intersection ID: 43371 | Main Street: BERNARDY_LN | Cross Street: SIMONTON_DR | Location: SE |

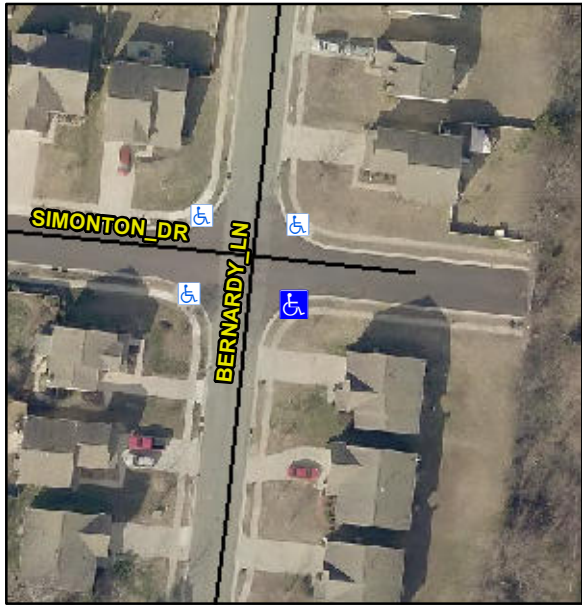
| Codes/Mitigation Info/Possible Solution | | | Field Measurements/Component Compliance | | | | | |
|---|---|--|---|---|---|---|---|---|
| | PROW/ADA: | | <b>Not Found, R304.5.3, R304.2.1, R304.2.2-Perp, R304.3.2-Para</b> | | | | | |
| | | | <b>Yes</b> | Ramp Width (in) | <b>48.0</b> | <b>No</b> | BlendTrans XSlope (%) | <b>4.0</b> |
| | | | <b>No</b> | Landing Width (in) | <b>35.0</b> | <b>Yes</b> | DWS Contrast? | <b>Yes</b> |
| | | | <b>No</b> | Landing Slope (%) | <b>3.6</b> | <b>Yes</b> | DWS Length (in) | <b>24.0</b> |
| | | | <b>No</b> | Landing X Slope (%) | <b>5.8</b> | <b>Yes</b> | DWS Full Width? | <b>Yes</b> |
| | | | <b>Yes</b> | Gutter Lip Ht (in) | <b>0.0</b> | <b>No</b> | Gutter X Slope (%) | <b>4.1</b> |
| | | | | | | <b>No</b> | Curb Slope (%) | <b>8.6</b> |

| Codes/Mitigation Info/Possible Solution | | | Field Measurements/Component Compliance | | | | | |
|---|---|--|---|---|---|---|---|---|
| | Possible Solutions: | | <b>Remove &amp; Replace Curb Ramp With Two New Directional Ramps or Equivalent. Remove &amp; Replace Gutter.</b> | | | | | |
