Access Compliance Report

Public Rights-of-Way

(Curb Ramps)

Intersection ID: 10748	Main Street: JOHNSON_ST	Cross Street: POLK_ST	Location: S
ADA ID: 5C3004C37441	Ramp Type: Combination1	Initial Pass/Fail: Fail	Overall Compliance: No
			Severity Score: 21.25

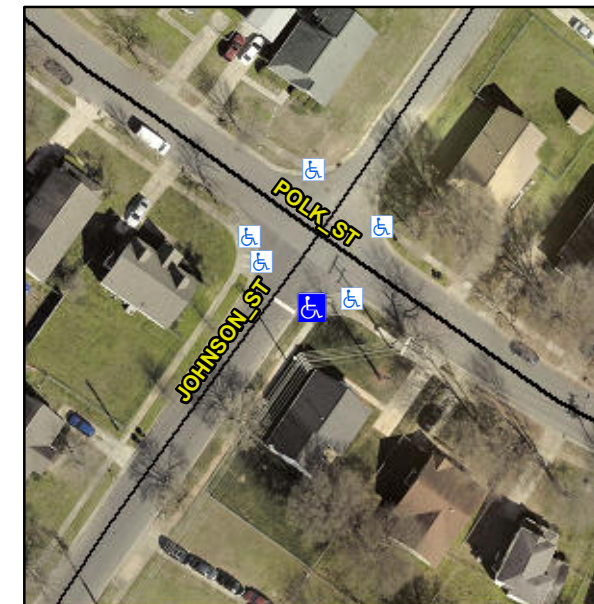
RT RP < 5%

Not Found, R304.5.1, R304.5.3

Compliance	Description	Data	Compliance	Description	Data
N/A	Ramp Length LT (in)	46.0	N/A	Ramp Length RT (in)	29.5
Yes	Ramp Width LT (in)	48.0	Yes	Ramp Width RT (in)	48.0
Yes	Ramp Slope LT (%)	5.7	Yes	Ramp Slope RT (%)	2.2
No	Ramp XSlope LT (%)	5.4	No	Ramp XSlope RT (%)	6.3
N/A	Ramp Length (in)	66.0	Yes	Ramp Slope (%)	5.5
No	Ramp Width (in)	44.0	Yes	Ramp XSlope (%)	0.4
N/A	Flare Type LT	N/A	N/A	Flare Type RT	N/A
N/A	Flare Slope LT (%)	N/A	N/A	Flare Slope RT (%)	N/A
N/A	Flare Traversable LT?	N/A	N/A	Flare Traversable RT?	N/A
N/A	Landing Length (in)	N/A	N/A	DWS Provided?	N/A
N/A	Landing Width (in)	N/A	N/A	DWS Contrast?	N/A
N/A	Landing Slope (%)	N/A	N/A	DWS Length (in)	N/A
N/A	Landing X Slope (%)	N/A	N/A	DWS Full Width?	N/A
N/A	Landing Curb? (Y/N)	N/A	N/A	DWS Offset (in)	N/A
N/A	Shared Landing?	N/A			
N/A	Gutter Ponding?	N/A	N/A	Gutter Slope (%)	N/A
N/A	Gutter Lip Ht (in)	N/A	N/A	Gutter X Slope (%)	N/A
N/A	Painted X Walk1?	No	N/A	Painted X Walk2?	N/A

Remove & Replace Entire Ramp.
