# Access Compliance Report

## Public Rights-of-Way

| Intersection ID: 47136 | Main Street: DARLINGTON_RD | Cross Street: HABITAT_MANOR_DR | Location: SE |
| ADA ID: 5C3FC0F0A1FA | Ramp Type: PerpDiag | Initial Pass/Fail: Fail | Overall Compliance: No |

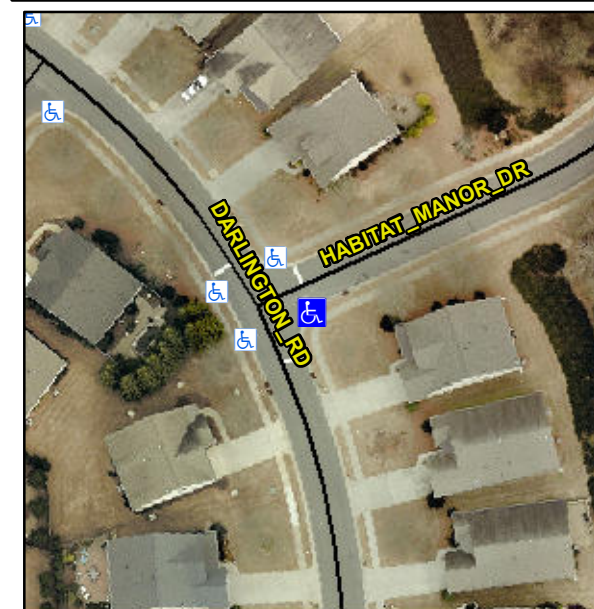
**Not Found, R304.5.1, R304.5.3**

| Compliance | Description | Data | Compliance | Description | Data |
|---|---|---|---|---|---|
| No | Ramp Width (in) | 30.0 | No | Ramp XSlope (%) | 3.2 |

**Remove & Replace Curb Ramp With Two New Directional Ramps or Equivalent.**
