# Access Compliance Report

## Public Rights-of-Way

### (Curb Ramps)

| Intersection ID: 9172 | Main Street: E_CRAIGHEAD_RD | Cross Street: N_TRYON_ST | Location: SW |

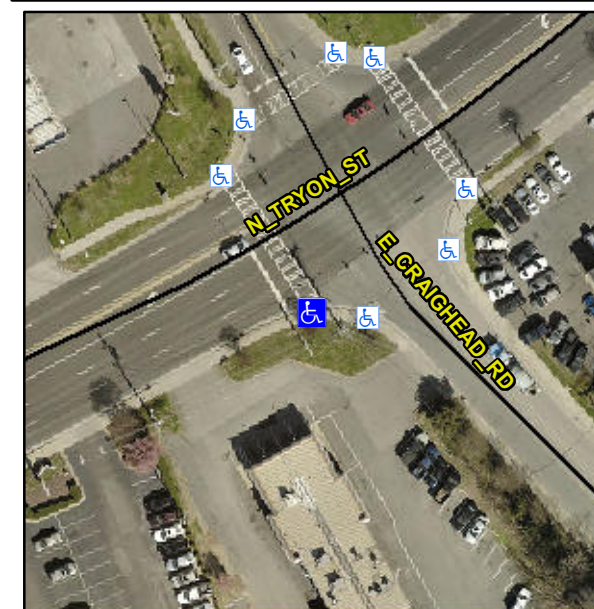
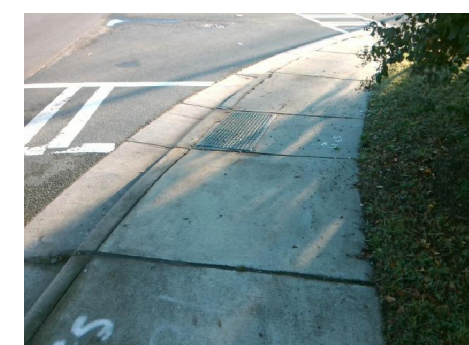
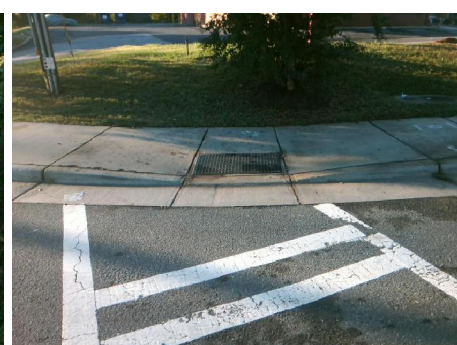
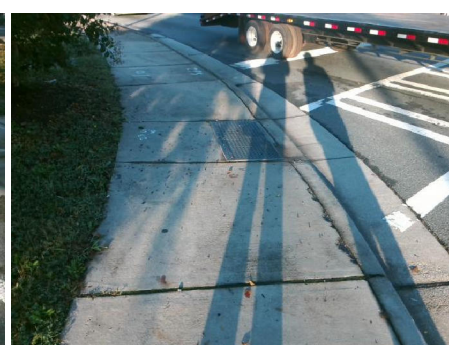
| ADA ID: 5C8A2C9136FF | Ramp Type: Perp | Initial Pass/Fail: Fail | Overall Compliance: No |

**Not Found, R304.5.1, R304.2.2, R304.5.3**

| Compliance | Description | Data | Compliance | Description | Data |
|---|---|---|---|---|---|
| N/A | Ramp Length (in) | 72.0 | No | Ramp Slope (%) | 8.5 |
| No | Ramp Width (in) | 44.0 | No | Ramp XSlope (%) | 2.3 |

**Remove & Replace Entire Ramp.**
