Access Compliance Report

Public Rights-of-Way (Curb Ramps)

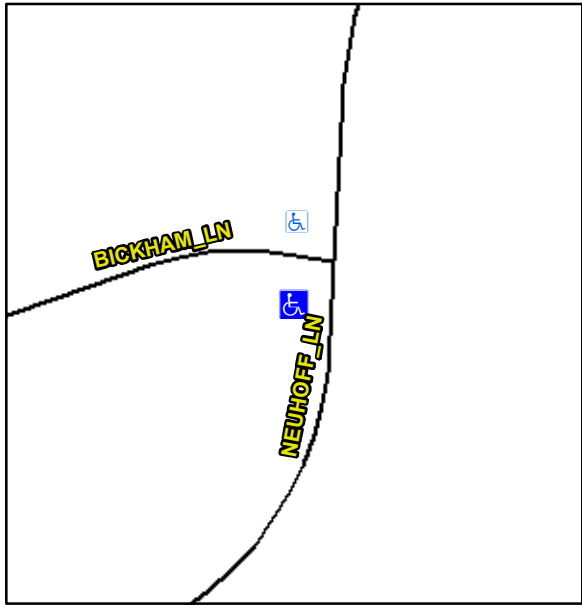
Intersection ID: 3889		Main Street: BICKHAM_LN		Cross Street: NEUHOFF_LN		Location: S											
ADA ID: 5CB645F3B032		Ramp Type: Directional1		Initial Pass/Fail: Fail		Overall Compliance: No		Severity Score: 25									
Codes/Mitigation Info/Possible Solution				Field Measurements/Component Compliance													
<div>

PROW/ADA: R304.5.3		N/A	Flare Slope LT (%)	N/A		N/A	Flare Slope RT (%)	0.0					
						N/A	Flare Traversable LT?	N/A		N/A	Flare Traversable RT?	N/A					
						N/A	Landing Length (in)	0.0		N/A	DWS Provided?	N/A					
						N/A	Landing Width (in)	0.0		N/A	DWS Contrast?	N/A					
						N/A	Landing Slope (%)	0.0		N/A	DWS Length (in)	N/A					
						N/A	Landing X Slope (%)	0.0		N/A	DWS Full Width?	N/A					
						N/A	Landing Curb? (Y/N)	N/A		N/A	DWS Offset LT (in)	N/A					
						N/A	Shared Landing?	N/A		N/A	DWS Offset RT (in)	N/A					
						N/A	Gutter Ponding?	Yes		N/A	Gutter Slope (%)	N/A					
						N/A	Gutter Lip Ht (in)	0.0		N/A	Gutter X Slope (%)	N/A					
				Total Cost: \$ 1600.00		N/A	Painted X Walk1?	No		Road Slope (%)		0.4					
						X Walk 1 Direction		To NW		Road X Slope (%)		4.1					
						X Walk 1 Width (in)		N/A		Clear Space?		N/A					
						X Walk 1 Slope (%)		0.4		N/A	Clear Space to XWalk (in)	N/A

X Walk 1 X Slope (%)		4.1		N/A	Storm Grate/Utility Hazard?	N/A					
						N/A	Ramp inside XWalk1?	N/A		Storm Grate/Utility Type							
						N/A	Any Obstructions?	N/A				N/A					
						Obstruction Type				Yes	Surface Condition? (G/P)	Good					
										N/A	Curb Slope (%)	12.1

</div> <div>Street 1 Name<div>BICKHAM LN</div></div> <div>Stop Condition-Street 1<div>StopSign</div></div> <div>Street 2 Name<div>N/A</div></div> <div>Stop Condition-Street 2<div>N/A</div></div>				Possible Solutions:		Compliance		Description		Data		Compliance		Description		Data	
				Remove & Replace Entire Ramp.		N/A	Ramp Length (in)	59.0		N/A	Grade Break?	N/A					
				Surveyor Notes: N/A		Yes	Ramp Width (in)	48.0		N/A	Grade Break Slope (%)	0.0					
						Yes	Ramp Slope (%)	7.5		N/A	Grade Break XSlope (%)	0.0					
						No	Ramp XSlope (%)	7.5									
						N/A	Flare Type LT	N/A		N/A	Flare Type RT	N/A
