Access Compliance Report

Public Rights-of-Way

(Curb Ramps)

Intersection ID: 7328	Main Street: MOORES_CHAPEL_RD	Cross Street: TILDEN_RD	Location:	E
ADA ID: 5CDD55C09C43	Ramp Type: Perp	Initial Pass/Fail: Fail	Overall Compliance: No	Severity Score: 18.75
Codes/Mitigation Info/Possible Solution		Field Measurements/Component Compliance

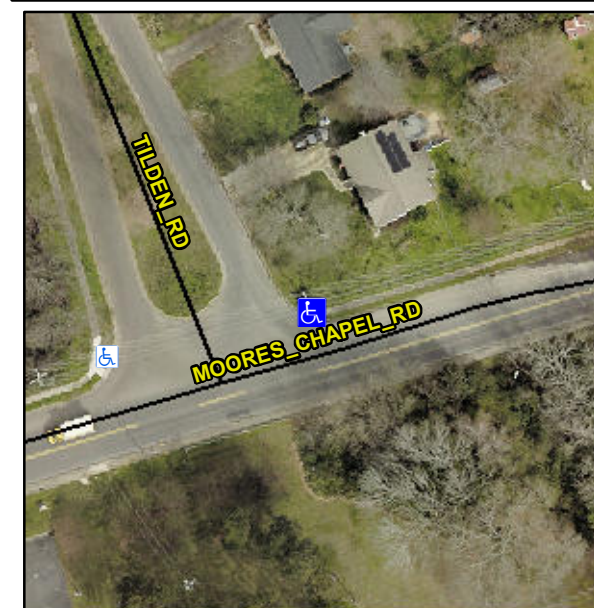
Not Found, R304.5.1, R304.5.3

Compliance	Description	Data	Compliance	Description	Data
N/A	Ramp Length (in)	43.0	Yes	Ramp Slope (%)	5.7
No	Ramp Width (in)	34.0	No	Ramp XSlope (%)	2.4
N/A	Flare Type LT	N/A	N/A	Flare Type RT	N/A
N/A	Flare Slope LT (%)	N/A	N/A	Flare Slope RT (%)	N/A
N/A	Flare Traversable LT?	N/A	N/A	Flare Traversable RT?	N/A
N/A	Landing Length (in)	N/A	N/A	DWS Provided?	N/A
N/A	Landing Width (in)	N/A	N/A	DWS Contrast?	N/A
N/A	Landing Slope (%)	N/A	N/A	DWS Length (in)	N/A
N/A	Landing X Slope (%)	N/A	N/A	DWS Full Width?	N/A
N/A	Landing Curb? (Y/N)	N/A	N/A	DWS Offset (in)	N/A
N/A	Shared Landing?	N/A			
N/A	Gutter Ponding?	N/A	N/A	Gutter Slope (%)	N/A
N/A	Gutter Lip Ht (in)	N/A	N/A	Gutter X Slope (%)	N/A
N/A	Painted X Walk1?	No	N/A	Painted X Walk2?	N/A
	X Walk 1 Direction	To W		X Walk 2 Direction	N/A
N/A	X Walk 1 Width (in)	N/A	N/A	X Walk 2 Width (in)	N/A
	X Walk 1 Slope (%)	1.5		X Walk 2 Slope (%)	N/A
	X Walk 1 X Slope (%)	2.6		X Walk 2 X Slope (%)	N/A

Remove & Replace Entire Ramp.
