# Access Compliance Report

## Public Rights-of-Way

### (Curb Ramps)

| Intersection ID: 4375 | Main Street: MALLARD_CREEK_RD | Cross Street: SILVER_BIRCH_DR | Location: W |

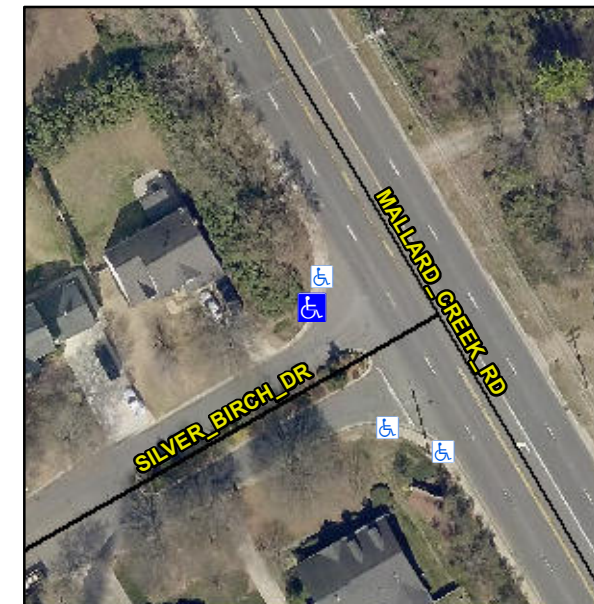
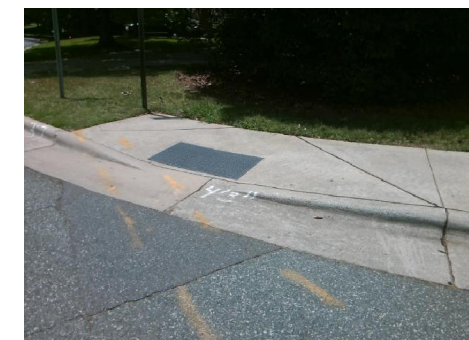
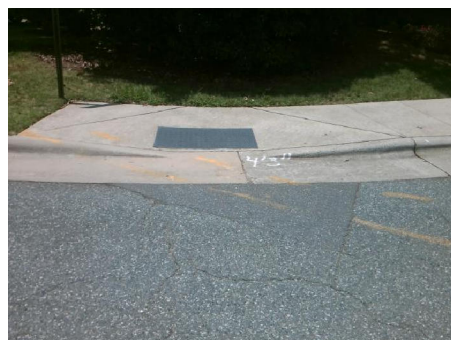
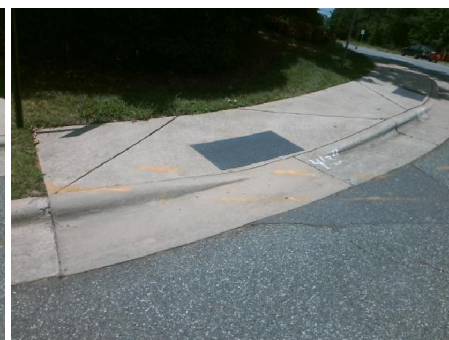
| ADA ID: 5CDE162E1D8D | Ramp Type: Perp | Initial Pass/Fail: Fail | Overall Compliance: No |
| Severity Score: 46.25 | | | |

**R304.5.1, R304.2.2, R304.5.3**

| Compliance | Description | Data | Compliance | Description | Data |
|---|---|---|---|---|---|
| N/A | Ramp Length (in) | 59.5 | No | Ramp Slope (%) | 10.6 |
| No | Ramp Width (in) | 36.0 | No | Ramp XSlope (%) | 8.4 |

**Remove & Replace Entire Ramp.**

Total Cost: \$ 1850.00
