Access Compliance Report

Public Rights-of-Way (Curb Ramps)

Intersection ID: 13795	Main Street: DENBUR_DR	Cross Street: LUSTERLEAF_HOLLY_RD	Location: S
ADA ID: 5D6C4449827B	Ramp Type: Perp	Initial Pass/Fail: Fail	Overall Compliance: No
Severity Score: 22.5			
Codes/Mitigation Info/Possible Solution		Field Measurements/Component Compliance

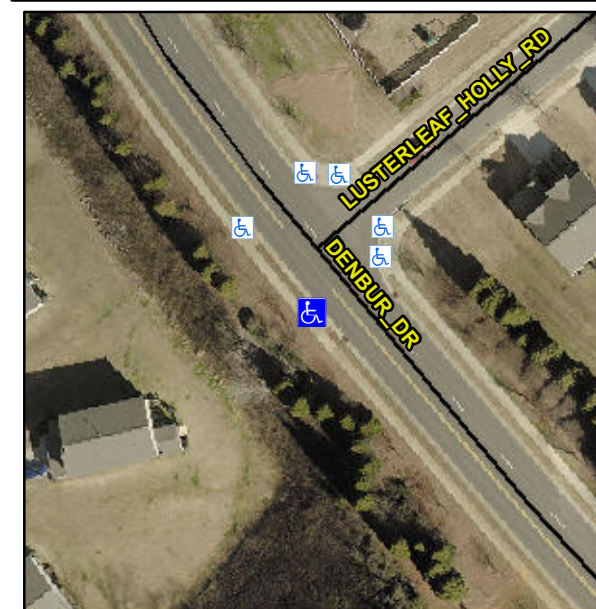
Not Found, R304.5.1, R304.2.2, R304.5.3

Compliance	Description	Data	Compliance	Description	Data
N/A	Ramp Length (in)	47.0	No	Ramp Slope (%)	9.9
No	Ramp Width (in)	47.0	No	Ramp XSlope (%)	3.8
N/A	Flare Type LT	N/A	N/A	Flare Type RT	N/A
N/A	Flare Slope LT (%)	N/A	N/A	Flare Slope RT (%)	N/A
N/A	Flare Traversable LT?	N/A	N/A	Flare Traversable RT?	N/A
N/A	Landing Length (in)	N/A	N/A	DWS Provided?	N/A
N/A	Landing Width (in)	N/A	N/A	DWS Contrast?	N/A
N/A	Landing Slope (%)	N/A	N/A	DWS Length (in)	N/A
N/A	Landing X Slope (%)	N/A	N/A	DWS Full Width?	N/A
N/A	Landing Curb? (Y/N)	N/A	N/A	DWS Offset (in)	N/A
N/A	Shared Landing?	N/A			
N/A	Gutter Ponding?	N/A	N/A	Gutter Slope (%)	N/A
N/A	Gutter Lip Ht (in)	N/A	N/A	Gutter X Slope (%)	N/A
N/A	Painted X Walk1?	No	N/A	Painted X Walk2?	N/A
	X Walk 1 Direction	To NE		X Walk 2 Direction	N/A
N/A	X Walk 1 Width (in)	N/A	N/A	X Walk 2 Width (in)	N/A
	X Walk 1 Slope (%)	2.4		X Walk 2 Slope (%)	N/A
	X Walk 1 X Slope (%)	3.2		X Walk 2 X Slope (%)	N/A

Remove & Replace Entire Ramp.
