Access Compliance Report

Public Rights-of-Way

(Curb Ramps)

Intersection ID: 49399	Main Street: CHILFORD_CT	Cross Street: HEREFORD_ST	Location: SE
ADA ID: 5D98B0EAFC23	Ramp Type: Perp	Initial Pass/Fail: Pass	Overall Compliance: No
Severity Score: 5			
Codes/Mitigation Info/Possible Solution		Field Measurements/Component Compliance

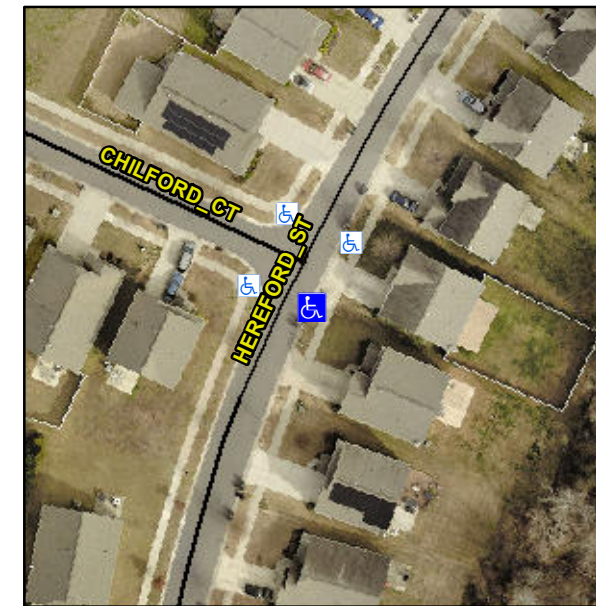
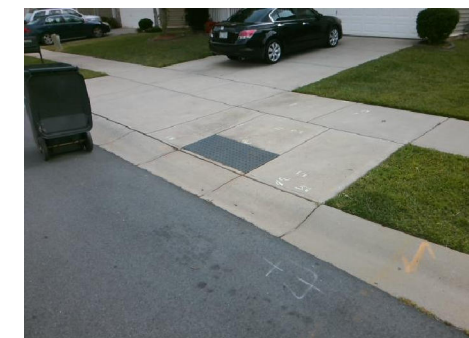
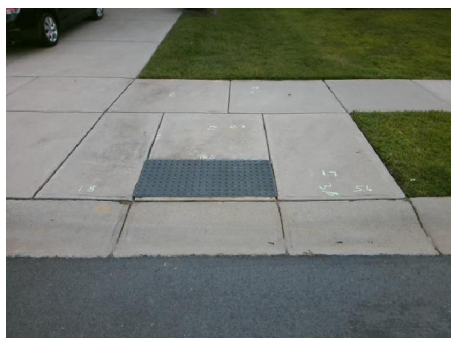
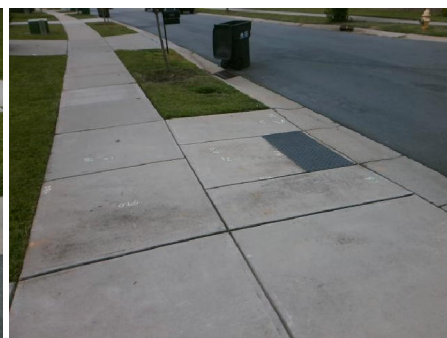
Not Found, R304.5.4

Compliance	Description	Data	Compliance	Description	Data
N/A	Ramp Length (in)	71.5	Yes	Ramp Slope (%)	7.1
Yes	Ramp Width (in)	48.0	Yes	Ramp XSlope (%)	0.7
N/A	Flare Type LT	Sloped	N/A	Flare Type RT	N/A
N/A	Flare Slope LT (%)	1.8	N/A	Flare Slope RT (%)	5.6
N/A	Flare Traversable LT?	Yes	N/A	Flare Traversable RT?	No
Yes	Landing Length (in)	59.0	Yes	DWS Provided?	Yes
Yes	Landing Width (in)	48.0	Yes	DWS Contrast?	Yes
Yes	Landing Slope (%)	1.6	Yes	DWS Length (in)	24.0
Yes	Landing X Slope (%)	1.9	Yes	DWS Full Width?	Yes
N/A	Landing Curb? (Y/N)	No	Yes	DWS Offset (in)	2.0
N/A	Shared Landing?	No			
Yes	Gutter Ponding?	No	No	Gutter Slope (%)	6.8
Yes	Gutter Lip Ht (in)	0.0	Yes	Gutter X Slope (%)	0.9
N/A	Painted X Walk1?	No	N/A	Painted X Walk2?	N/A
	X Walk 1 Direction	To NW		X Walk 2 Direction	N/A
N/A	X Walk 1 Width (in)	N/A	N/A	X Walk 2 Width (in)	N/A
	X Walk 1 Slope (%)	3.8		X Walk 2 Slope (%)	N/A
	X Walk 1 X Slope (%)	1.7		X Walk 2 X Slope (%)	N/A

N/A	Ramp inside XWalk1?	N/A	N/A	Ramp inside XWalk2?	N/A
	Road Slope (%)	N/A	N/A	Clear Space?	Yes
	Road X Slope (%)	N/A	N/A	Clear Space to XWalk (in)	N/A
Yes	Any Obstructions?	No	Yes	Storm Grate/Utility Hazard?	No
	Obstruction Type			Storm Grate/Utility Type	
		N/A			N/A
			Yes	Surface Condition? (G/P)	Good

**Remove & Replace Entire Ramp.
Remove & Replace Gutter.**
