Access Compliance Report Public Rights-of-Way (Curb Ramps)

Intersection ID: 10025963 Main Street: ELM_LN Cross Street: N/A Location: NW Severity Score: **Overall Compliance: No** ADA ID: 5DA31F0620E6 Ramp Type: Para Initial Pass/Fail: Fail 12.5

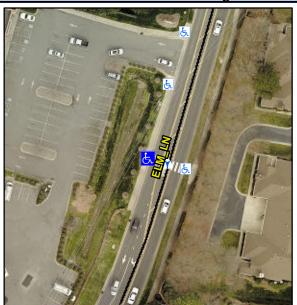
Field Measurements/Component Compliance								
Comp	oliance Description	Data	Comp	liance Description	Data			
N/A	Ramp Length LT (in)	73.0	N/A	Ramp Length RT (in)	70.0			
Yes	Ramp Width LT (in)	60.0	Yes	Ramp Width RT (in)	60.0			
Yes	Ramp Slope LT (%)	5.8	No	Ramp Slope RT (%)	8.5			
Yes	Ramp XSlope LT (%)	0.8	Yes	Ramp XSlope RT (%)	1.9			
N/A	Landing Length (in)	N/A	N/A	DWS Provided?	N/A			
N/A	Landing Width (in)	N/A	N/A	DWS Contrast?	N/A			
N/A	Landing Slope (%)	N/A	N/A	DWS Length (in)	N/A			
N/A	Landing X Slope (%)	N/A	N/A	DWS Full Width?	N/A			
N/A	Landing Curb? (Y/N)	N/A	N/A	DWS Offset (in)	N/A			
N/A	Shared Landing?	N/A						
N/A	Gutter Ponding?	N/A	N/A	Gutter Slope (%)	N/A			
N/A	Gutter Lip Ht (in)	N/A	N/A	Gutter X Slope (%)	N/A			
N/A	Painted X Walk1?	Yes	N/A	Painted X Walk2?	N/A			
	X Walk 1 Direction	To SE		X Walk 2 Direction	N/A			
N/A	X Walk 1 Width (in)	122.0	N/A	X Walk 2 Width (in)	N/A			
	X Walk 1 Slope (%)	7.4		X Walk 2 Slope (%)	N/A

ossible Solution	
ossible Solutions:	Co
Remove & Replace Entire Ramp.	N/A
·	Ye
	Ye
	Ye
	N/A
	N/A
surveyor Notes:	N/A
N/A	N/A
	N/A
	N/A
	N/A
ROW/ADA:	N/A
R304.3.2	N/A
	N/A
	N/A
