Access Compliance Report

Public Rights-of-Way

(Curb Ramps)

Intersection ID: 16396	Main Street: BEAL_ST	Cross Street: N_WENDOVER_RD	Location: E
ADA ID: 5DE17A84C090	Ramp Type: Combination1	Initial Pass/Fail: Fail	Overall Compliance: No
Severity Score: 22.5			
Codes/Mitigation Info/Possible Solution		Field Measurements/Component Compliance

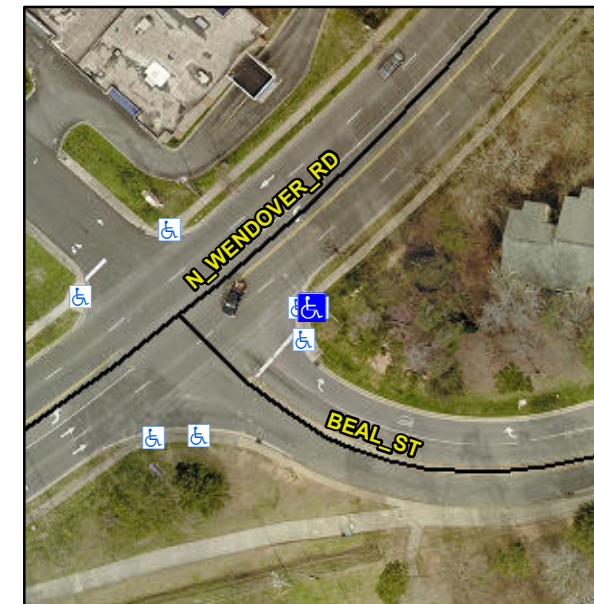
LT RP < 5%

Not Found, R304.5.1, R304.2.2, R304.5.3, R304.3.2

Remove & Replace Entire Ramp.
