Access Compliance Report

Public Rights-of-Way

(Curb Ramps)

Intersection ID: 12433	Main Street: HARGROVE_AV	Cross Street: MIDLAND_AV	Location: NE
ADA ID: 5DFB0CBF4A18	Ramp Type: ParaDiag	Initial Pass/Fail: Pass	Overall Compliance: No
		Severity Score: 0

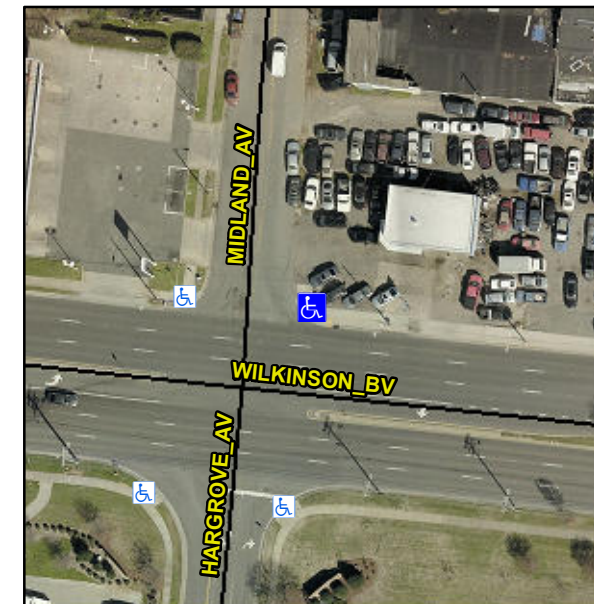
LT RP < 5%

Not Found, R304.2.1, R305.2

Compliance	Description	Data	Compliance	Description	Data
N/A	Ramp Length LT (in)	48.0	N/A	Ramp Length RT (in)	64.0
Yes	Ramp Width LT (in)	82.0	Yes	Ramp Width RT (in)	83.0
Yes	Ramp Slope LT (%)	1.9	Yes	Ramp Slope RT (%)	6.6
Yes	Ramp XSlope LT (%)	1.9	Yes	Ramp XSlope RT (%)	1.3
Yes	Landing Length (in)	82.0	Yes	DWS Provided?	Yes
No	Landing Width (in)	47.0	Yes	DWS Contrast?	Yes
Yes	Landing Slope (%)	0.3	Yes	DWS Length (in)	24.0
Yes	Landing X Slope (%)	0.6	Yes	DWS Full Width?	Yes
N/A	Landing Curb? (Y/N)	Yes	No	DWS Offset (in)	5.0
N/A	Shared Landing?	No			
Yes	Gutter Ponding?	No	Yes	Gutter Slope (%)	4.6
Yes	Gutter Lip Ht (in)	0.0	Yes	Gutter X Slope (%)	0.5
N/A	Painted X Walk1?	No	N/A	Painted X Walk2?	No
	X Walk 1 Direction	To W		X Walk 2 Direction	To S
N/A	X Walk 1 Width (in)	N/A	N/A	X Walk 2 Width (in)	N/A
	X Walk 1 Slope (%)	1.0		X Walk 2 Slope (%)	1.8
	X Walk 1 X Slope (%)	0.9		X Walk 2 X Slope (%)	0.0
N/A	Ramp inside XWalk1?	N/A	N/A	Ramp inside XWalk2?	N/A

Road Slope (%)	0.4	N/A	Clear Space?	Yes
	Road X Slope (%)	1.3	N/A	Clear Space to XWalk (in)	N/A
Yes	Any Obstructions?	No	Yes	Storm Grate/Utility Hazard?	No
	Obstruction Type			Storm Grate/Utility Type	
		N/A			N/A
			Yes	Surface Condition? (G/P)	Good
			Replace Curb Slope (%)		9.3

Remove & Replace Curb Ramp With Two New Directional Ramps or Equivalent.
