# Access Compliance Report

## Public Rights-of-Way

### (Curb Ramps)

Intersection ID: 12388	Main Street: BERRYHILL_RD	Cross Street: GREENLAND_AV	Location: NE
ADA ID: 5E006A02A75A	Ramp Type: Combination1Diag	Initial Pass/Fail: Fail	Overall Compliance: No
		Severity Score: 0

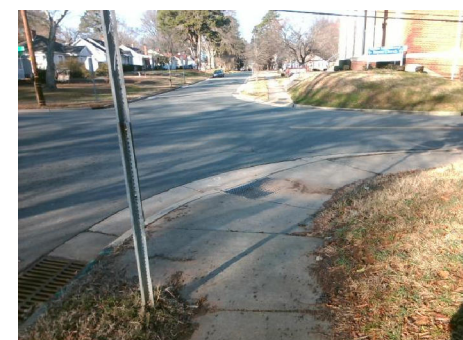
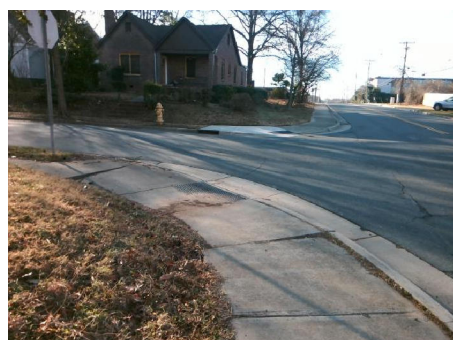
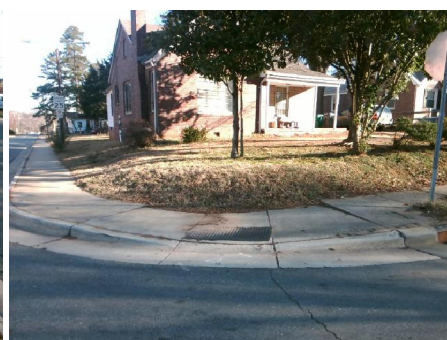
**RP & LT RP < 5%**

**Not Found, R304.5.1, R304.5.1, R304.5.3**

Compliance	Description	Data	Compliance	Description	Data
N/A	Ramp Length LT (in)	50.0	N/A	Ramp Length RT (in)	65.0
Yes	Ramp Width LT (in)	63.0	No	Ramp Width RT (in)	40.5
Yes	Ramp Slope LT (%)	1.9	Yes	Ramp Slope RT (%)	6.8
Yes	Ramp XSlope LT (%)	1.0	Yes	Ramp XSlope RT (%)	0.3
N/A	Ramp Length (in)	62.0	Yes	Ramp Slope (%)	0.3
No	Ramp Width (in)	40.5	No	Ramp XSlope (%)	4.0
N/A	Flare Type LT	N/A	N/A	Flare Type RT	N/A
N/A	Flare Slope LT (%)	N/A	N/A	Flare Slope RT (%)	N/A
N/A	Flare Traversable LT?	N/A	N/A	Flare Traversable RT?	N/A
N/A	Landing Length (in)	N/A	N/A	DWS Provided?	N/A
N/A	Landing Width (in)	N/A	N/A	DWS Contrast?	N/A
N/A	Landing Slope (%)	N/A	N/A	DWS Length (in)	N/A
N/A	Landing X Slope (%)	N/A	N/A	DWS Full Width?	N/A
N/A	Landing Curb? (Y/N)	N/A	N/A	DWS Offset (in)	N/A
N/A	Shared Landing?	N/A			
N/A	Gutter Ponding?	N/A	N/A	Gutter Slope (%)	N/A
N/A	Gutter Lip Ht (in)	N/A	N/A	Gutter X Slope (%)	N/A
N/A	Painted X Walk1?	No	N/A	Painted X Walk2?	No

**Remove & Replace Curb Ramp With Two New Directional Ramps or Equivalent.**
