Access Compliance Report

Public Rights-of-Way

(Curb Ramps)

Intersection ID: 45174	Main Street: LINDEN_TREE_LN	Cross Street: SOCIETY_ST	Location:	SE
ADA ID: 5E052F8FFEAA	Ramp Type: Perpendicular Diagonal	Initial Pass/Fail: Fail	Overall Compliance: No	Severity Score: 10
Codes/Mitigation Info/Possible Solution		Field Measurements/Component Compliance

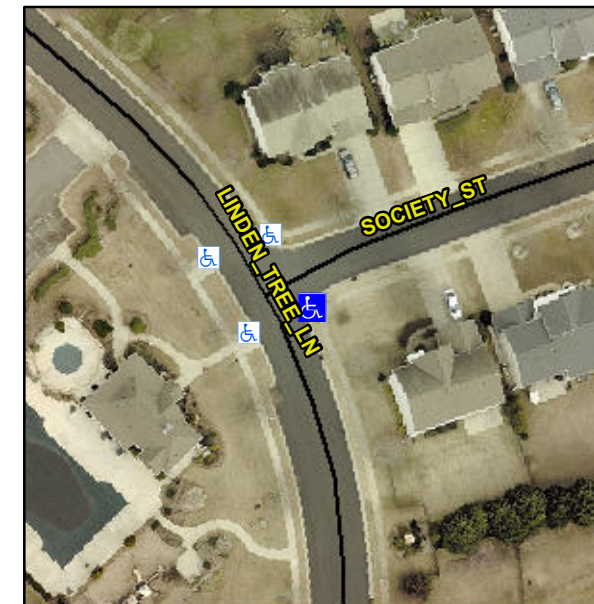
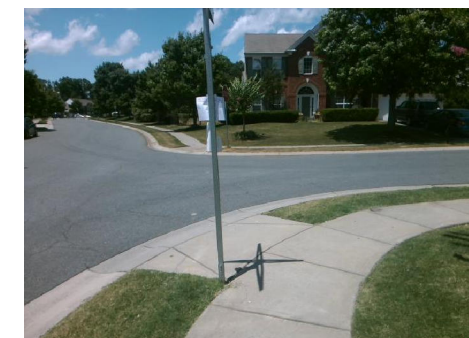
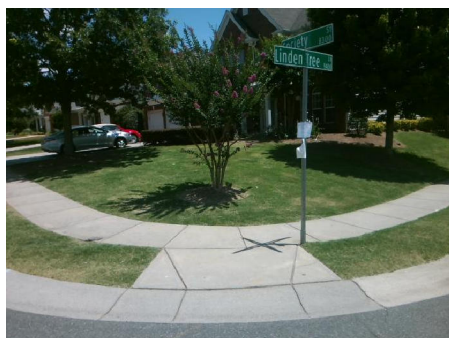
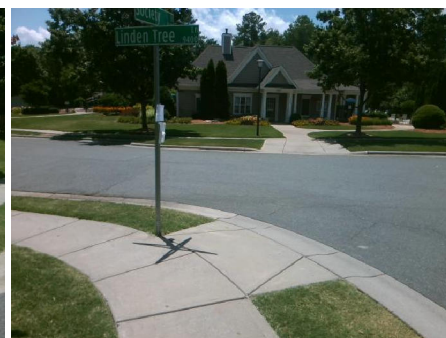
Not Found, R304.5.1, R304.5.3

Compliance	Description	Data	Compliance	Description	Data
N/A	Ramp Length (in)	47.0	Yes	Ramp Slope (%)	5.4
No	Ramp Width (in)	47.0	No	Ramp XSlope (%)	4.3
N/A	Flare Type LT	N/A	N/A	Flare Type RT	N/A
N/A	Flare Slope LT (%)	N/A	N/A	Flare Slope RT (%)	N/A
N/A	Flare Traversable LT?	N/A	N/A	Flare Traversable RT?	N/A
N/A	Landing Length (in)	N/A	N/A	DWS Provided?	N/A
N/A	Landing Width (in)	N/A	N/A	DWS Contrast?	N/A
N/A	Landing Slope (%)	N/A	N/A	DWS Length (in)	N/A
N/A	Landing X Slope (%)	N/A	N/A	DWS Full Width?	N/A
N/A	Landing Curb? (Y/N)	N/A	N/A	DWS Offset (in)	N/A
N/A	Shared Landing?	N/A			
N/A	Gutter Ponding?	N/A	N/A	Gutter Slope (%)	N/A
N/A	Gutter Lip Ht (in)	N/A	N/A	Gutter X Slope (%)	N/A
N/A	Painted X Walk1?	No	N/A	Painted X Walk2?	No
	X Walk 1 Direction	To NW		X Walk 2 Direction	To SW
N/A	X Walk 1 Width (in)	N/A	N/A	X Walk 2 Width (in)	N/A
	X Walk 1 Slope (%)	3.2		X Walk 2 Slope (%)	0.0
	X Walk 1 X Slope (%)	1.8		X Walk 2 X Slope (%)	2.0

Possible Solutions:

Remove & Replace Curb Ramp With Two New Directional Ramps or Equivalent.
