# Access Compliance Report

## Public Rights-of-Way

### (Curb Ramps)

| Intersection ID: 45512 | Main Street: GINHOUSE_LN | Cross Street: HEDGEROW_PARK_RD | Location: SE |

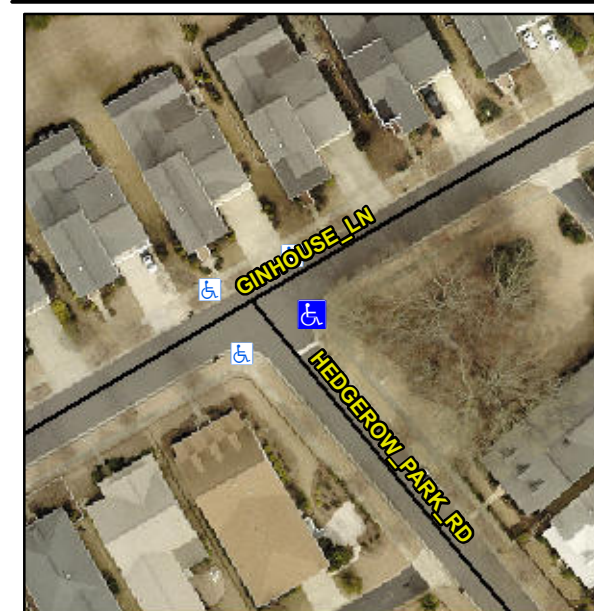
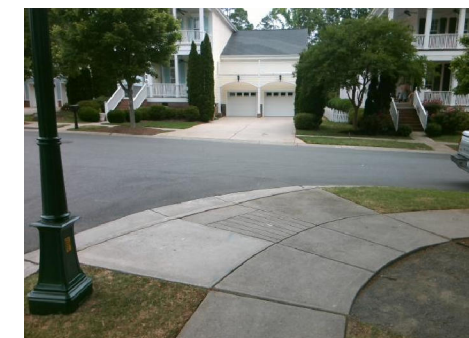
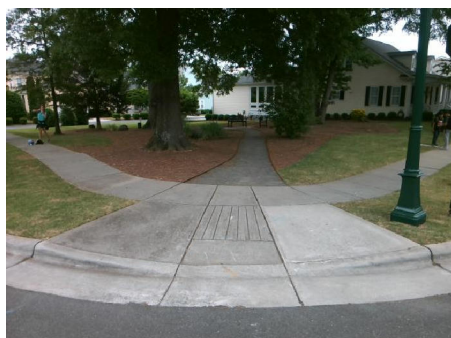
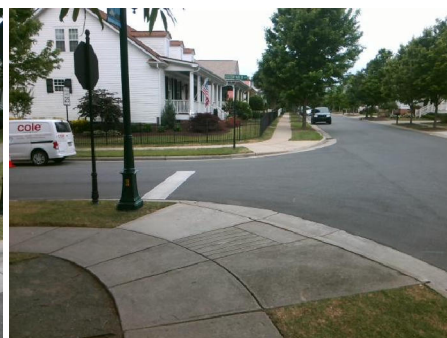
| ADA ID: 5E0B56133AB3 | Ramp Type: PerpDiag | Initial Pass/Fail: Fail | Overall Compliance: No |
| Severity Score: 17.5 | | | |

**Not Found, R304.5.1**

| Compliance | Description | Data | Compliance | Description | Data |
|---|---|---|---|---|---|
| No | Ramp Width (in) | 33.0 | Yes | Ramp XSlope (%) | 0.2 |

**Remove & Replace Curb Ramp With Two New Directional Ramps or Equivalent.**
