Access Compliance Report Public Rights-of-Way (Curb Ramps)

Intersection ID: 18538Main Street:SENECA_PLCross Street:SOUTH_BVLocation:NEADA ID: 5E6E4D4F1F37Ramp Type:PerpInitial Pass/Fail:FailOverall Compliance:NoSeverity Score:21.25

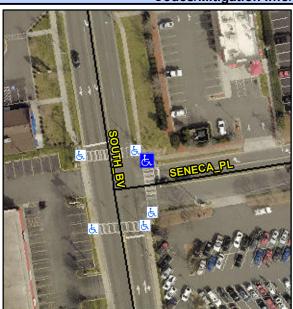
Comp	liance Description	Data	Comp	liance Description	Data
N/A	N/A Ramp Length (in)		No	Ramp Slope (%)	8.6
No	Ramp Width (in)	47.0	Yes	Ramp XSlope (%)	1.0
N/A	Flare Type LT	N/A	N/A	Flare Type RT	N/A
N/A	Flare Slope LT (%)	N/A	N/A	Flare Slope RT (%)	N/A
N/A	Flare Traversable LT?	N/A	N/A	Flare Traversable RT?	N/A
N/A	Landing Length (in)	N/A	N/A	DWS Provided?	N/A
N/A	Landing Width (in)	N/A	N/A	DWS Contrast?	N/A
N/A	Landing Slope (%)	N/A	N/A	DWS Length (in)	N/A
N/A	Landing X Slope (%)	N/A	N/A	DWS Full Width?	N/A
N/A	Landing Curb? (Y/N)	N/A	N/A	DWS Offset (in)	N/A
N/A	Shared Landing?	N/A			
N/A	Gutter Ponding?	N/A	N/A	Gutter Slope (%)	N/A
N/A	Gutter Lip Ht (in)	N/A	N/A	Gutter X Slope (%)	N/A
N/A	Painted X Walk1?	Yes	N/A	Painted X Walk2?	N/A
	X Walk 1 Direction	To S		X Walk 2 Direction	N/A
N/A	X Walk 1 Width (in)	112.0	N/A	X Walk 2 Width (in)	N/A
	X Walk 1 Slope (%)	0.9		X Walk 2 Slope (%)	N/A
	X Walk 1 X Slope (%)	0.7		X Walk 2 X Slope (%)	N/A

N/A	Ramp inside XWalk1?	Yes	N/A	Ramp inside XWalk2?	N/A
	Road Slope (%)	N/A	N/A	Clear Space?	N/A
	Road X Slope (%)	N/A	N/A	Clear Space to XWalk (in)	N/A
N/A	Any Obstructions?	N/A	N/A	Storm Grate/Utility Hazard?	N/A
	Obstruction Type			Storm Grate/Utility Type	
		N/A			N/A
			Yes	Surface Condition? (G/P)	Good

Possible Solutions:	<u>c</u>
Remove & Replace Entire Ramp.	
	N
	N
	N
	N
	N
Surveyor Notes:	N
N/A	N
	N
	N
	N
PROW/ADA:	N
Not Found, R304.5.1, R304.2.2	N
	N
	N
	N
