Access Compliance Report

Public Rights-of-Way

(Curb Ramps)

Intersection ID: 48516	Main Street: GALLERIA CLUB LN	Cross Street: GALLERIA BV	Location: S
ADA ID: 5E7A8699B8E6	Ramp Type: PerpDiag	Initial Pass/Fail: Fail	Overall Compliance: No
Codes/Mitigation Info/Possible Solution		Field Measurements/Component Compliance	
Severity Score: 8.75

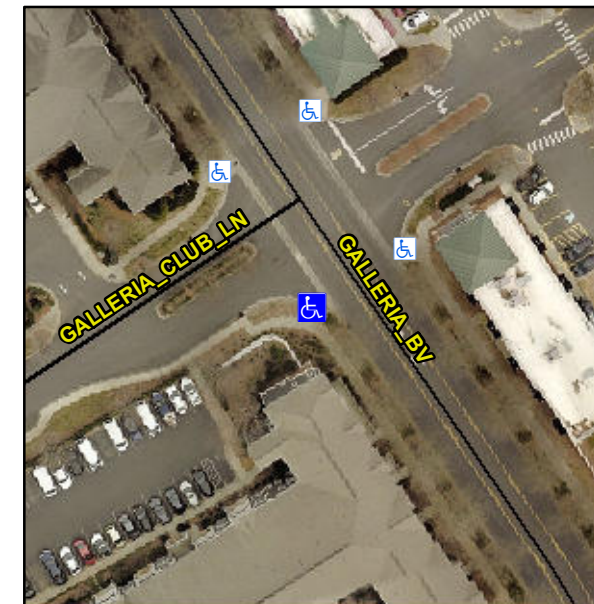
Not Found, R304.5.1

Compliance	Description	Data	Compliance	Description	Data
N/A	Ramp Length (in)	96.0	Yes	Ramp Slope (%)	7.0
No	Ramp Width (in)	39.0	Yes	Ramp XSlope (%)	0.6
N/A	Flare Type LT	N/A	N/A	Flare Type RT	N/A
N/A	Flare Slope LT (%)	N/A	N/A	Flare Slope RT (%)	N/A
N/A	Flare Traversable LT?	N/A	N/A	Flare Traversable RT?	N/A
N/A	Landing Length (in)	N/A	N/A	DWS Provided?	N/A
N/A	Landing Width (in)	N/A	N/A	DWS Contrast?	N/A
N/A	Landing Slope (%)	N/A	N/A	DWS Length (in)	N/A
N/A	Landing X Slope (%)	N/A	N/A	DWS Full Width?	N/A
N/A	Landing Curb? (Y/N)	N/A	N/A	DWS Offset (in)	N/A
N/A	Shared Landing?	N/A			
N/A	Gutter Ponding?	N/A	N/A	Gutter Slope (%)	N/A
N/A	Gutter Lip Ht (in)	N/A	N/A	Gutter X Slope (%)	N/A
N/A	Painted X Walk1?	No	N/A	Painted X Walk2?	No
	X Walk 1 Direction	To NE		X Walk 2 Direction	To NW
N/A	X Walk 1 Width (in)	N/A	N/A	X Walk 2 Width (in)	N/A
	X Walk 1 Slope (%)	3.5		X Walk 2 Slope (%)	1.8
	X Walk 1 X Slope (%)	0.9		X Walk 2 X Slope (%)	1.1

Remove & Replace Curb Ramp With Two New Directional Ramps or Equivalent.
