# Access Compliance Report

## Public Rights-of-Way

| Intersection ID: 46806 | Main Street: ADLIN_AV | Cross Street: RED_BIRCH_DR | Location: SE |
| ADA ID: 5EF263224A38 | Ramp Type: Perp | Initial Pass/Fail: Fail | Overall Compliance: No |

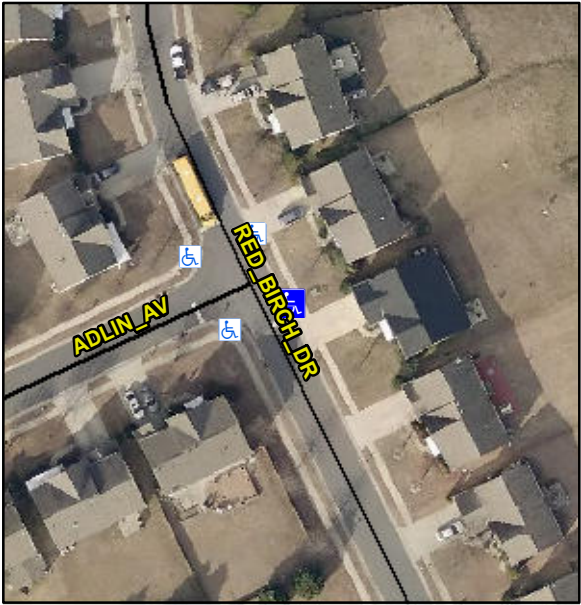
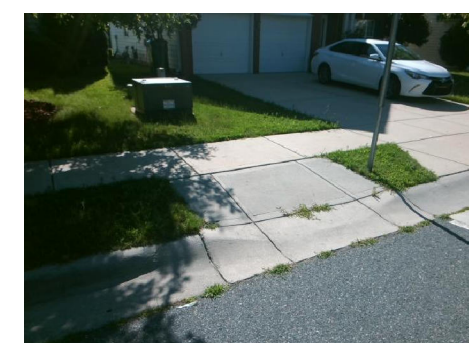
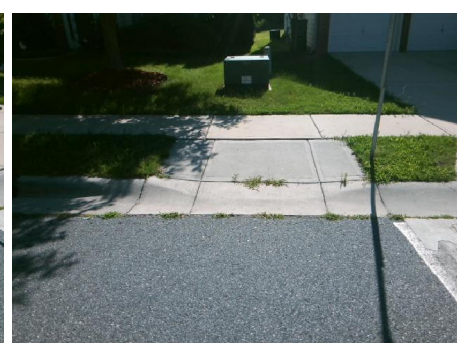
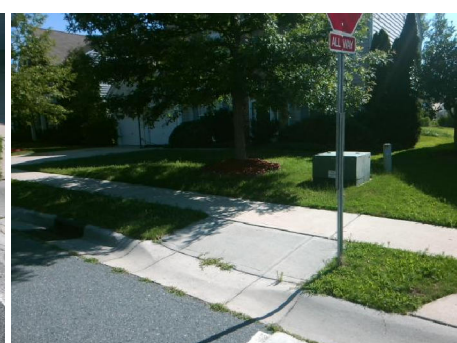
| | | Severity Score: 25 | |

| Codes/Mitigation Info/Possible Solution | | | Field Measurements/Component Compliance | | |
|---|---|---|---|---|---|
| | <b>Remove &amp; Replace Entire Ramp.</b> | | <b>No</b> | Ramp Length (in) | 46.0 |
| <p>Surveyor Notes:</p> <p><b>N/A</b></p> <p>PROW/ADA:</p> <p><b>R304.2.2</b></p> | | | <b>N/A</b> | Flare Type RT | N/A |

| Codes/Mitigation Info/Possible Solution | | | Field Measurements/Component Compliance | | |
|---|---|---|---|---|---|
| | Possible Solutions: | | <b>Compliance</b> | <b>Description</b> | <b>Data</b> |
